White Cloud Dam Disposition Feasibility Study

White Cloud Dam, White Cloud, Michigan

February 14, 2025 Project 2302435

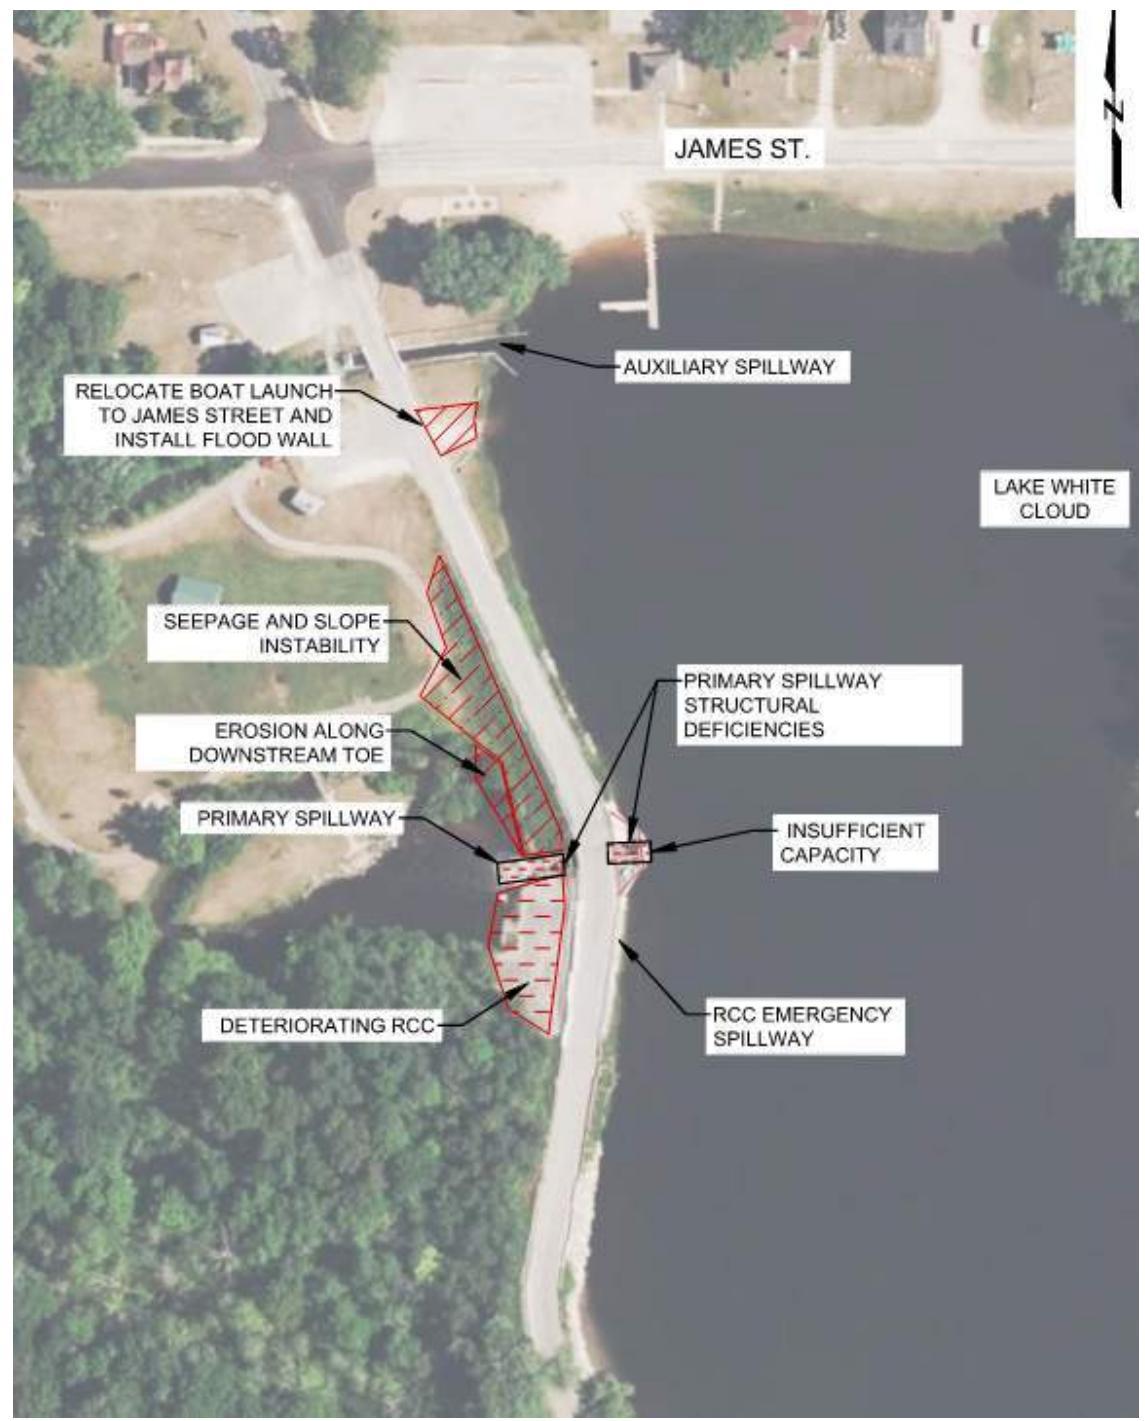
Figure 4-1: Dam Safety Deficiencies

Table 4-1 provides an ala carte menu of alternatives, where applicable, to address each dam safety deficiency identified. Some alternatives address multiple deficiencies. It is expected that a range in costs for initial dam rehabilitation is likely and is dependent on the selection of alternatives to address deficiencies. This list was provided to assist the City with identifying smaller projects that might be advanced to address dam safety deficiencies as funding becomes available.
