White Cloud Dam Disposition Feasibility Study

White Cloud Dam, White Cloud, Michigan

February 14, 2025 Project 2302435

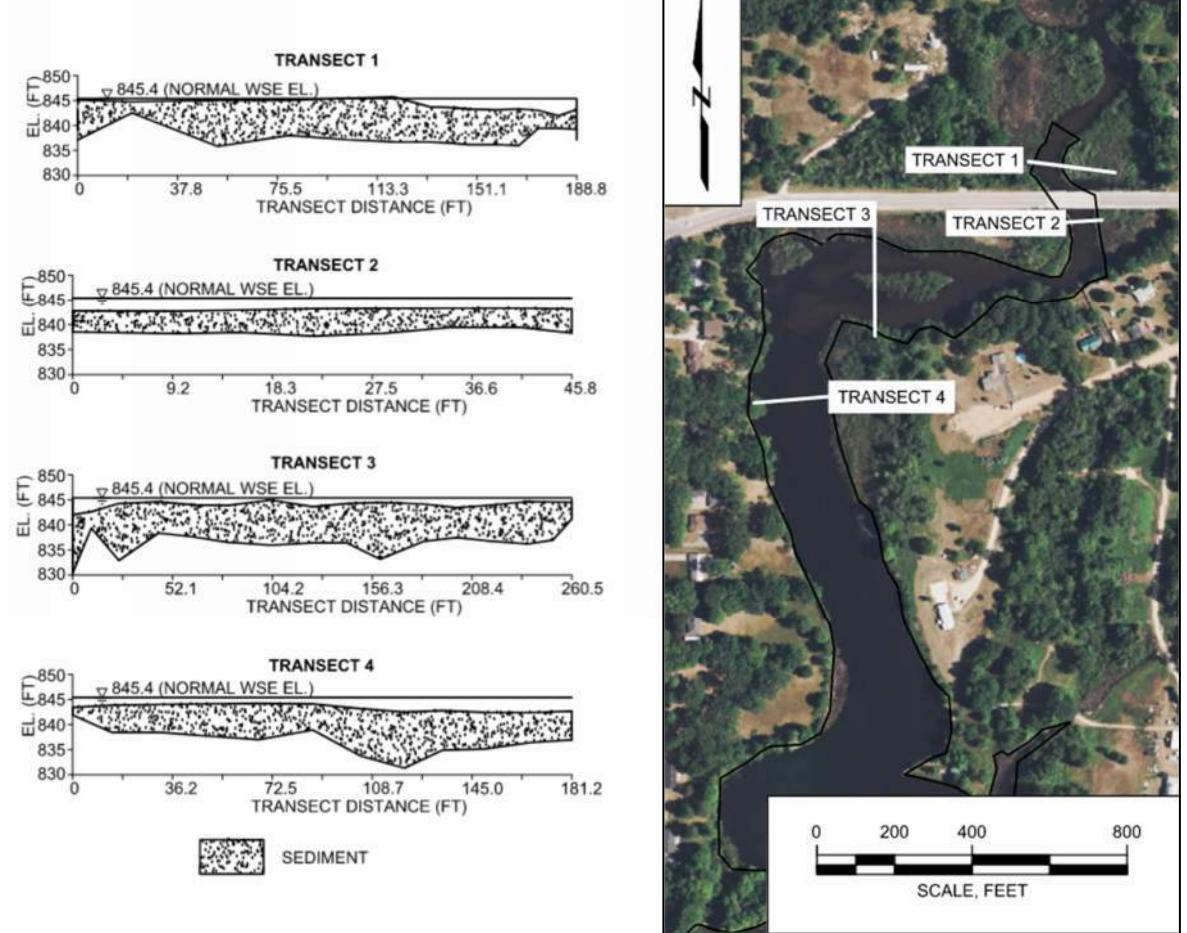
Figure 2-3: Depth of Refusal Cross Sections

In Transect 2, located downstream of the E. Pine Hill Ave overpass, the minimum existing grade elevation is 843.3 feet, with a minimum depth of refusal at 837.7 feet, showing approximately 5.5 feet of accumulated sediment at this location. To avoid impacts to the E. Pine Hill Avenue bridge, at this stage in design Transect 2 serves as an approximation of the tie-in point for a restored river channel following potential dam removal. It is possible that restoration design could target a tie in point further upstream, however grade control would be required at the E. Pine Hill Avenue bridge to avoid unintended impacts to the bridge foundation and additional data collection would be required upstream to determine where impounded sediment terminates. The depth of refusal at Transects 3 and 4 deepens further, measuring at 833.2 feet and 831.32 feet, respectively. The deeper refusal depths observed within Transects 3 and 4 likely indicate the location of the historic channel.

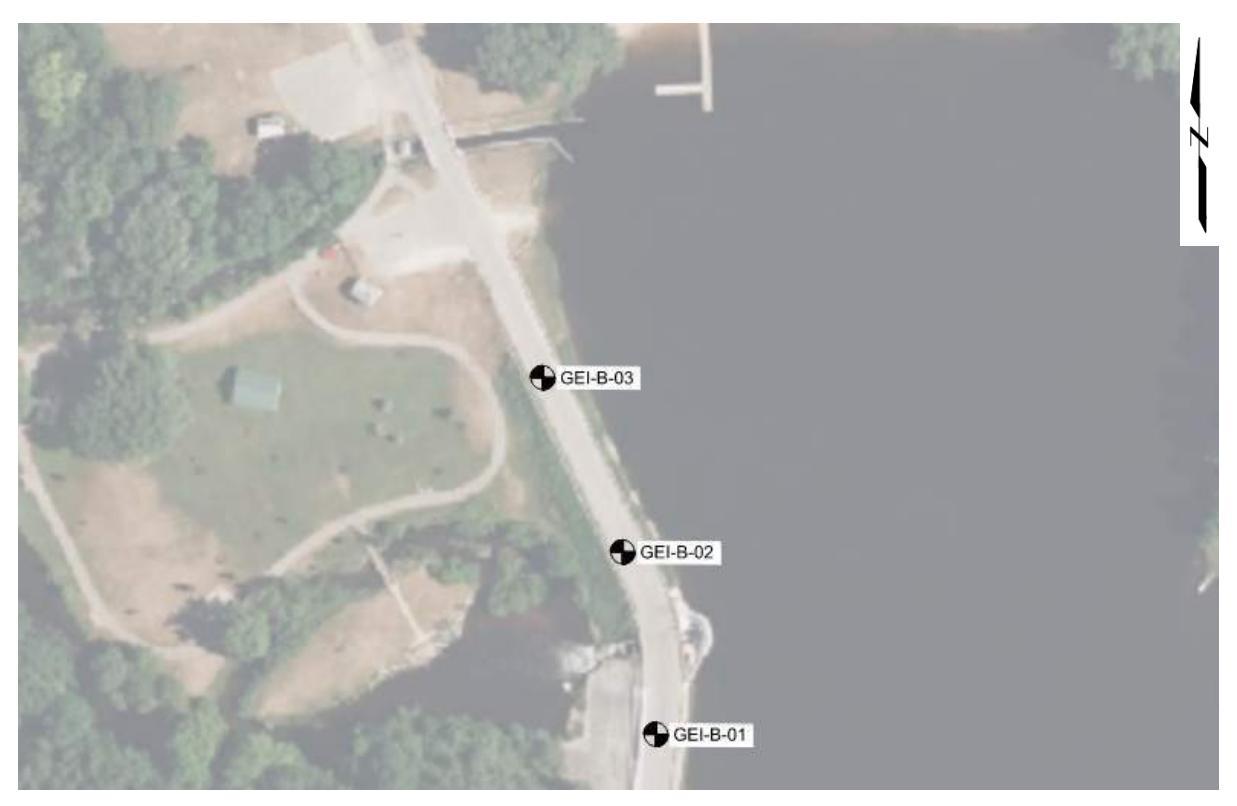
Figure 2-6: Boring Location Diagram

Based on the findings in Boring B-01 the 1989 OMM plans for the reconstruction of the left embankment do not appear to document actual construction conditions. The plans depict a clay core directly beneath the existing roadway and the soil boring indicates a subsurface profile consisting mainly of granular backfill. The proposed clay core was never encountered.

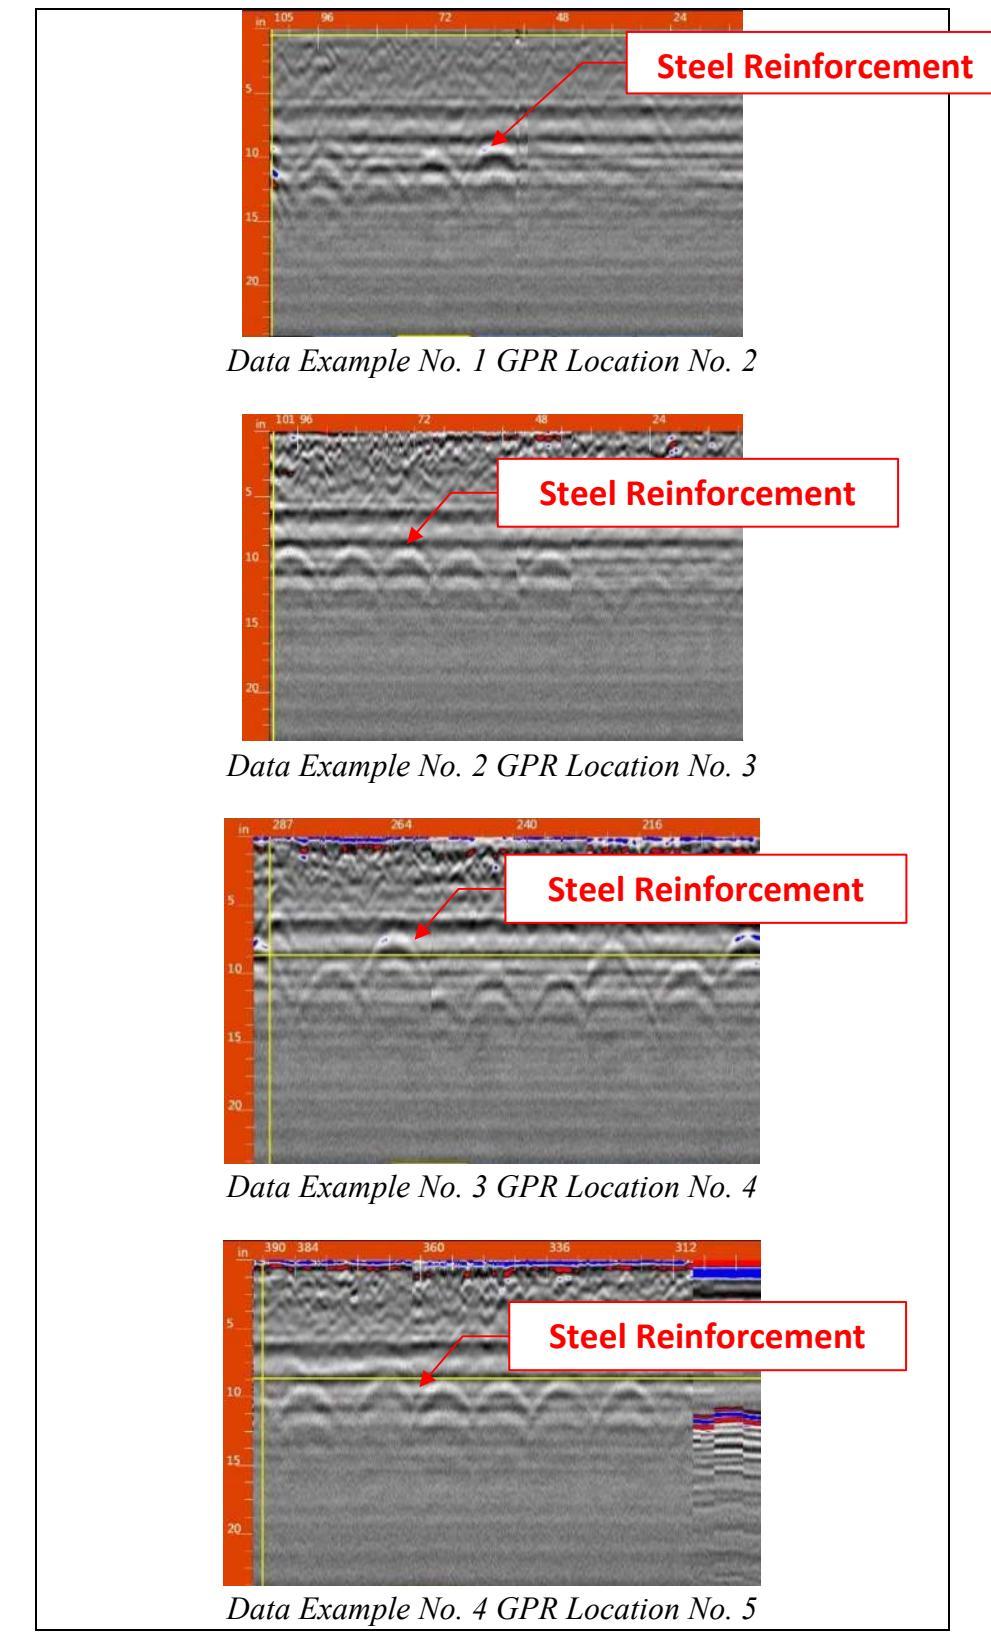
Figure 2-8: GPR Data Examples

The steel reinforcement in the upper portion of the spillway side walls are visible in the data profiles as a series of small, inverted parabolas at test location Nos. 2 and 3 (Figure 2-8). Horizontal steel reinforcing bars were observed to have 8 to 9 inches of concrete cover and were observed to be on a 12-inch spacing 48 inches above the spillway slab. A potential lower mat of horizontal steel reinforcement is sometimes visible at about 11 to 12 inches depth from 0 to 48 inches above the spillway slab . Vertical steel reinforcement was not observed in the spillway wing and side wall areas scanned during this investigation. The spillway side walls are estimated to be 12 inches thick at the locations tested during this investigation.

The steel reinforcement in the spillway slab was observed to be constructed on a 12-inch by 12-inch pattern with 9 to 10 inches of concrete cover at both GPR test location Nos. 4 and 5. The spillway slab is estimated to be 12 inches or greater along the tested portions of the spillway slab. The GPR profiles performed at this site did not identify areas with a characteristic voided response below the spillway slab.

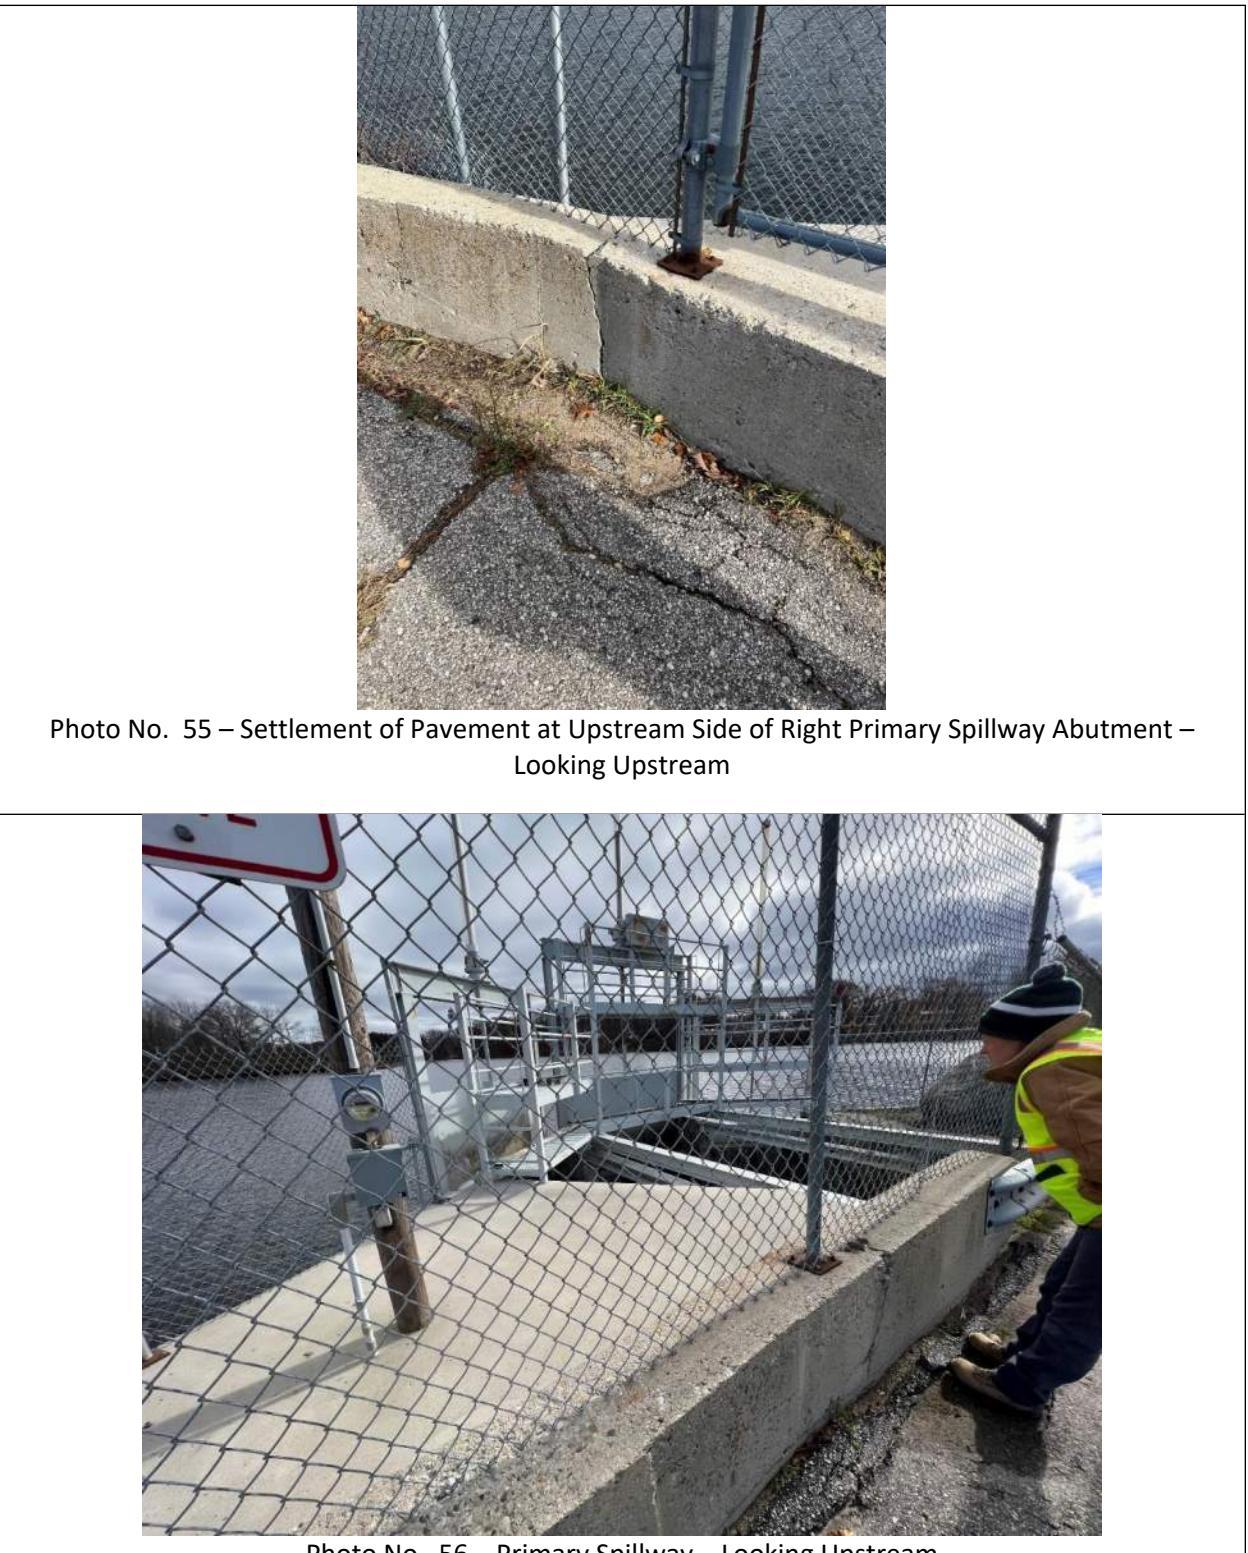
Photo No. 56 – Primary Spillway – Looking Upstream

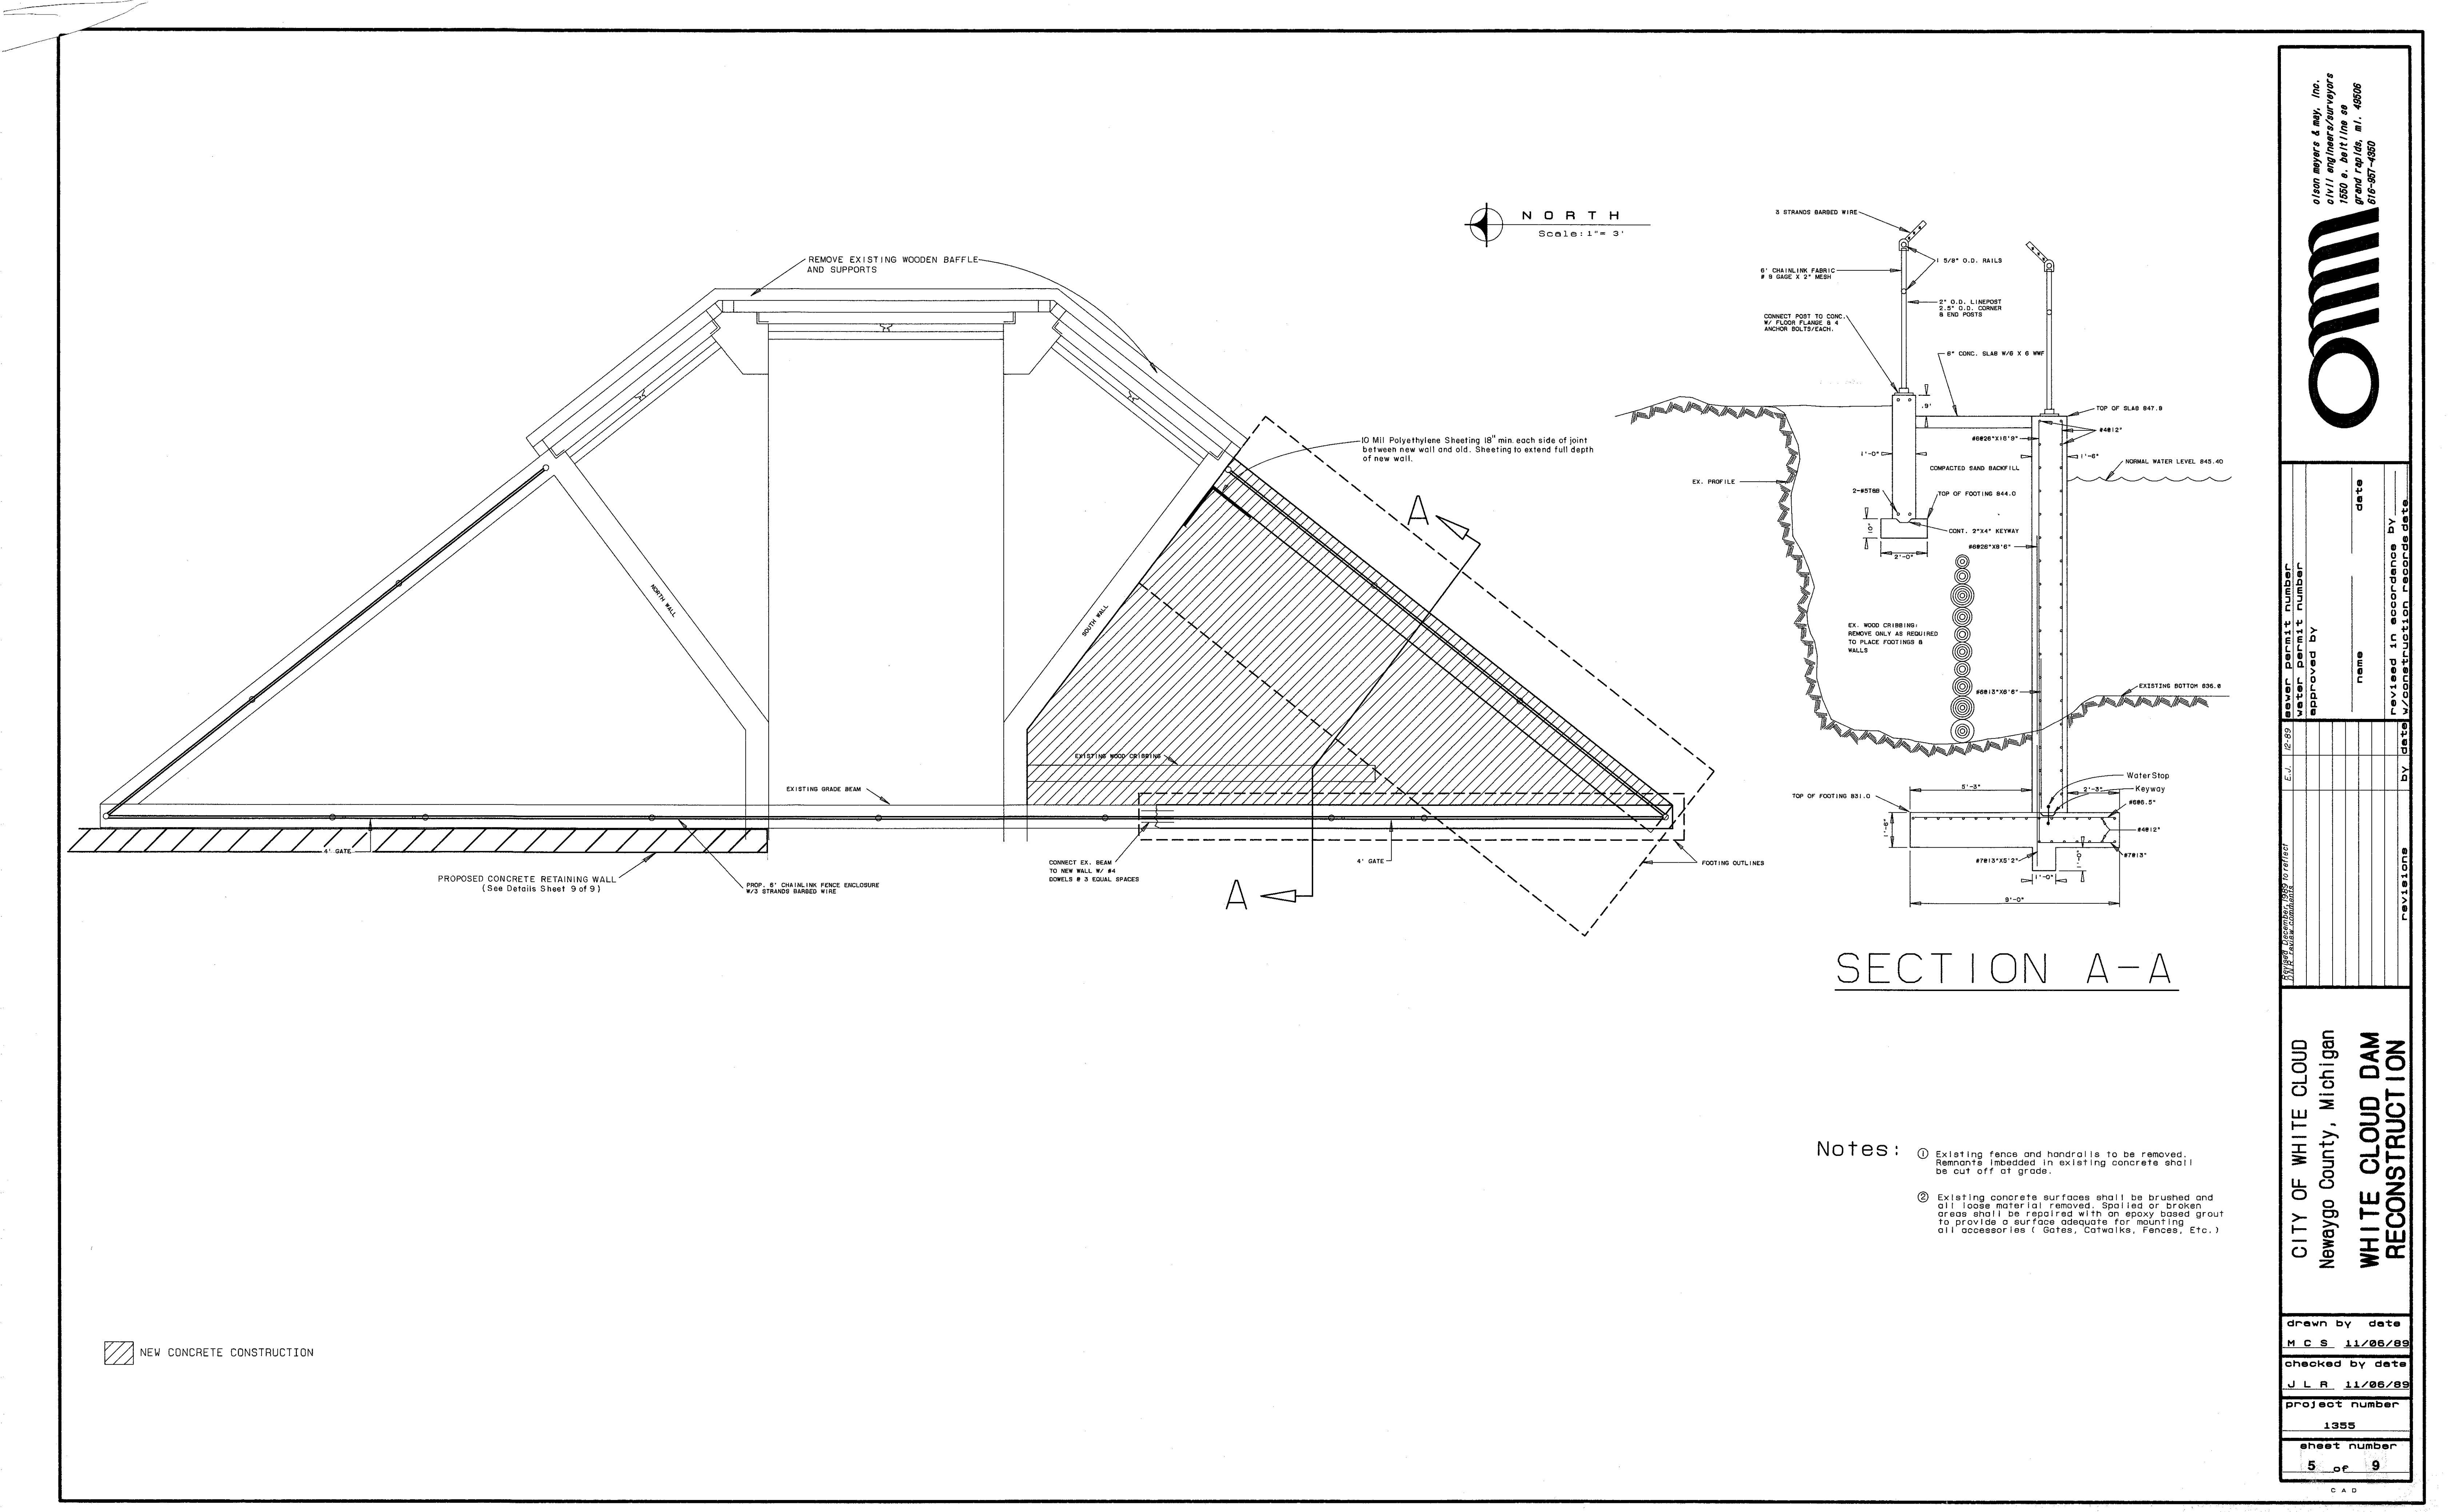
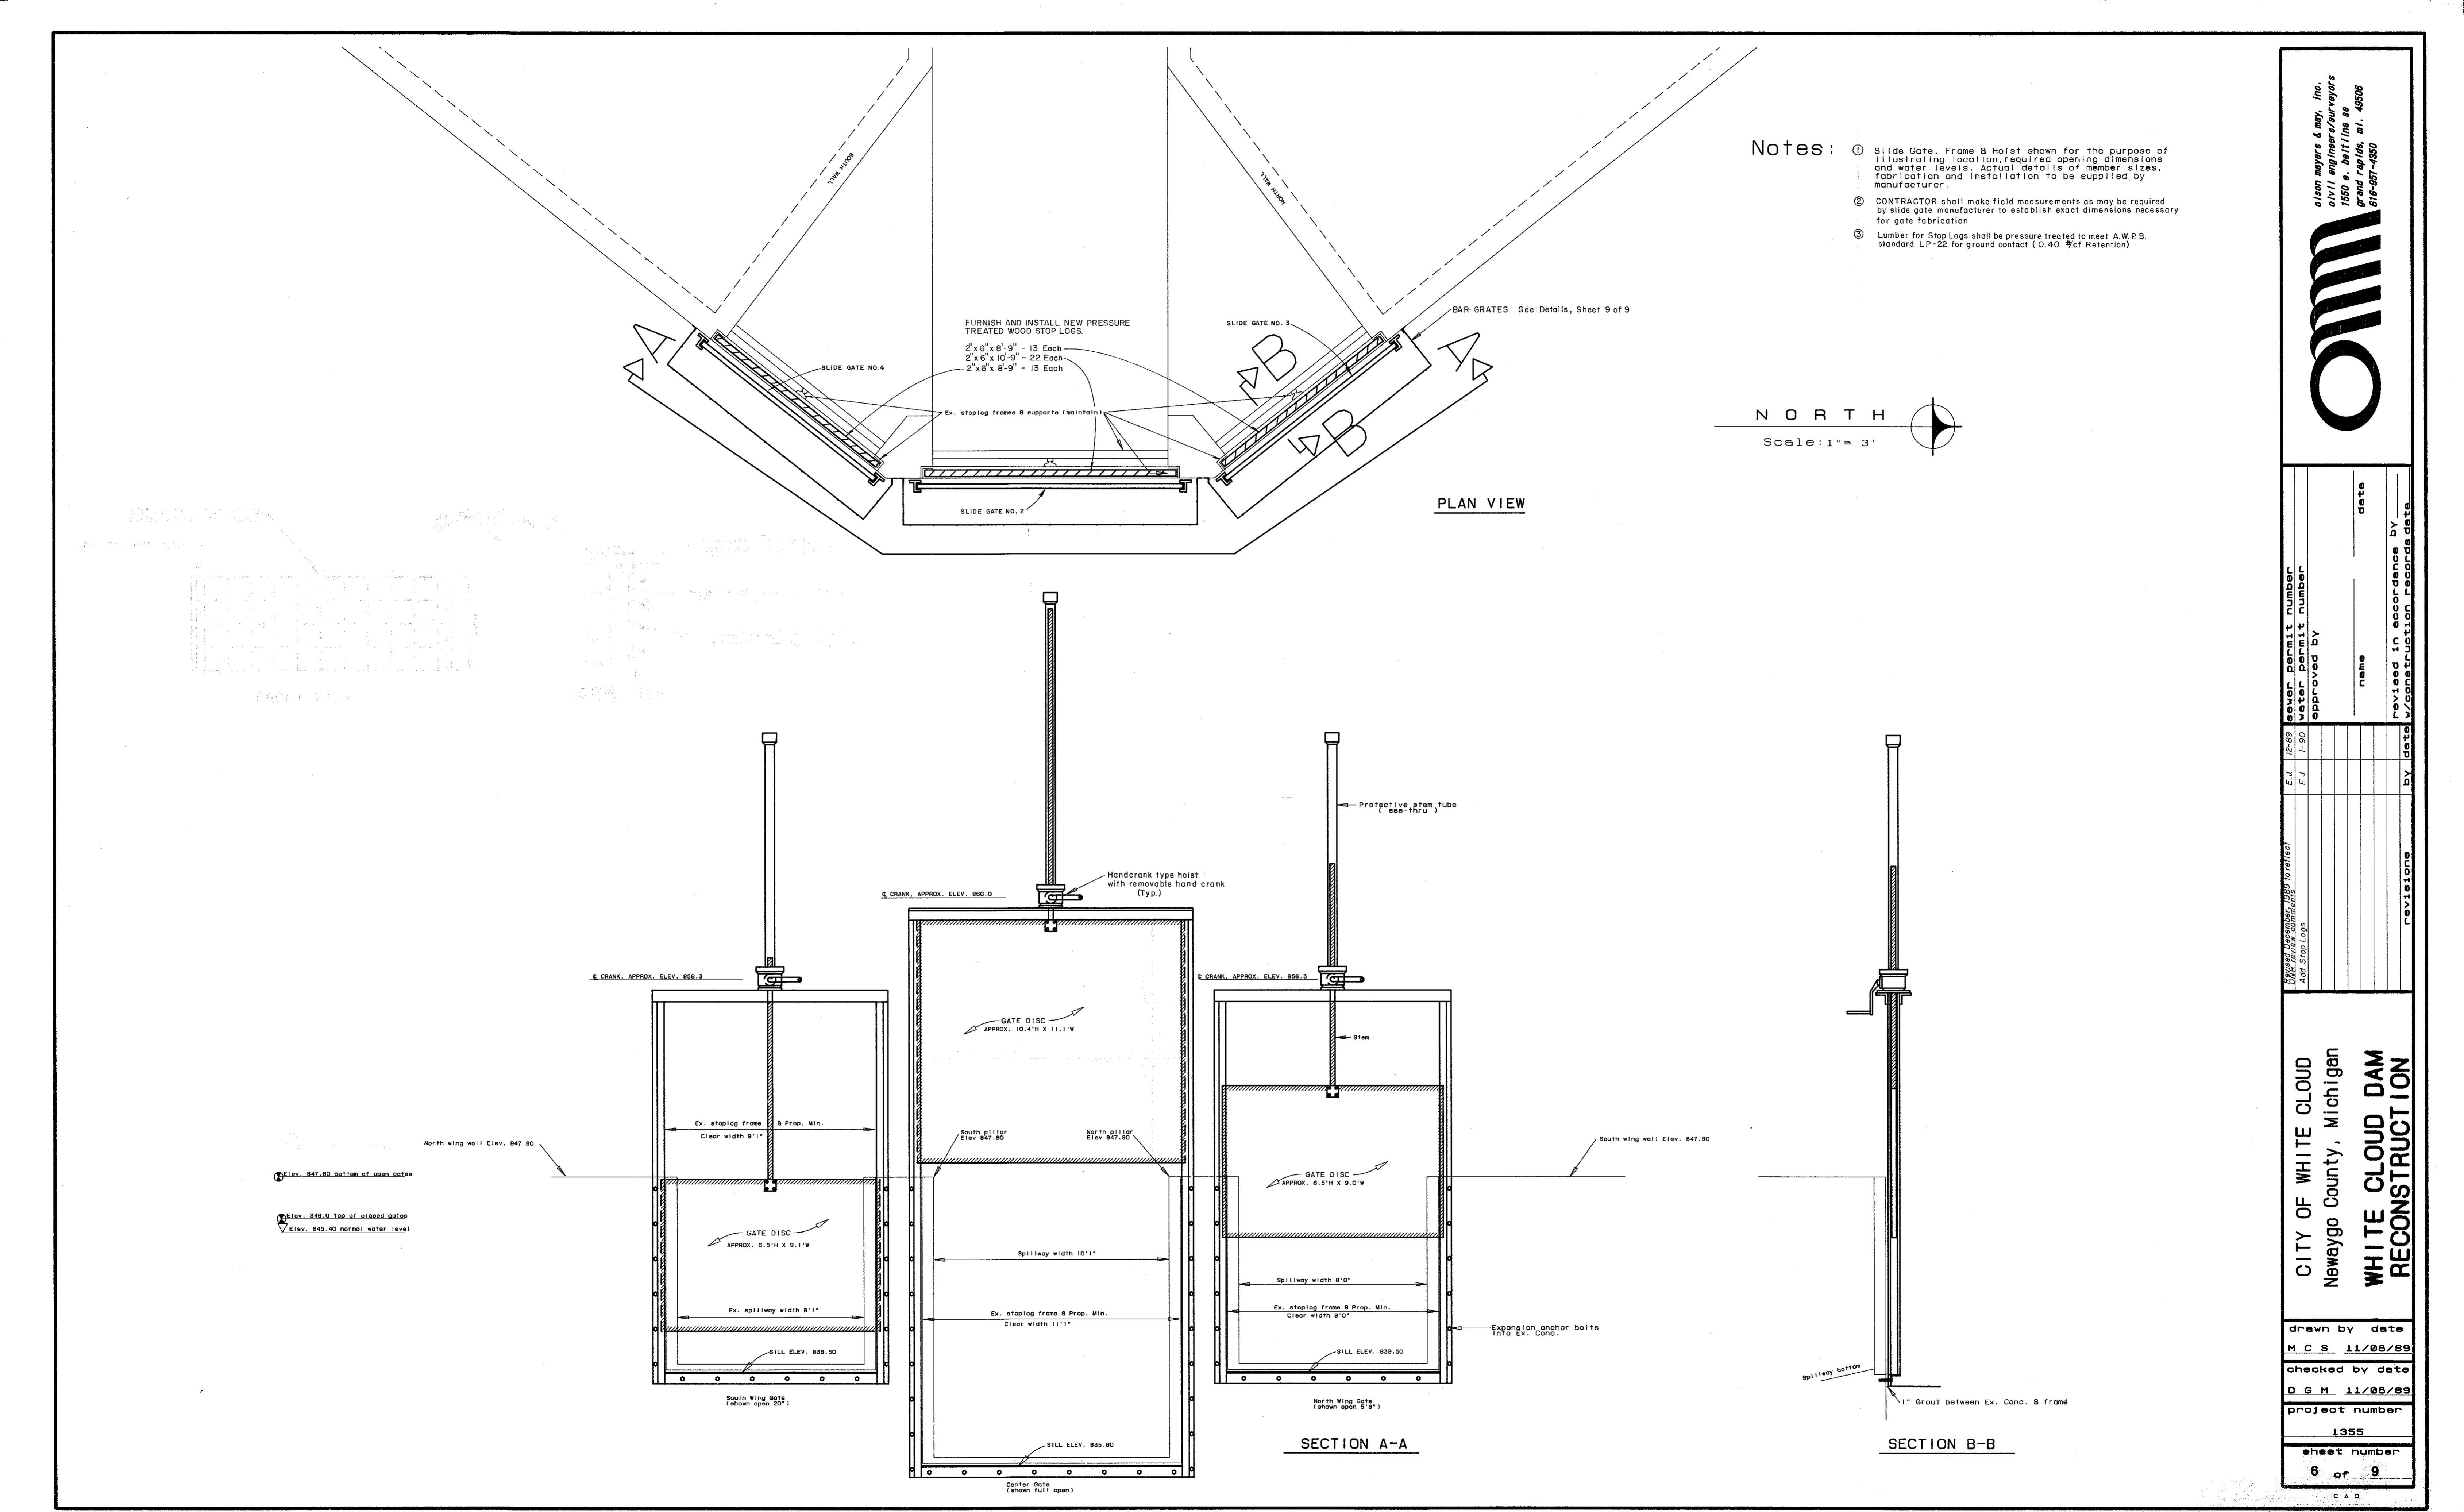
#### FENCING AND WINGWALL REPAIR: PRINCIPAL SPILLWAY

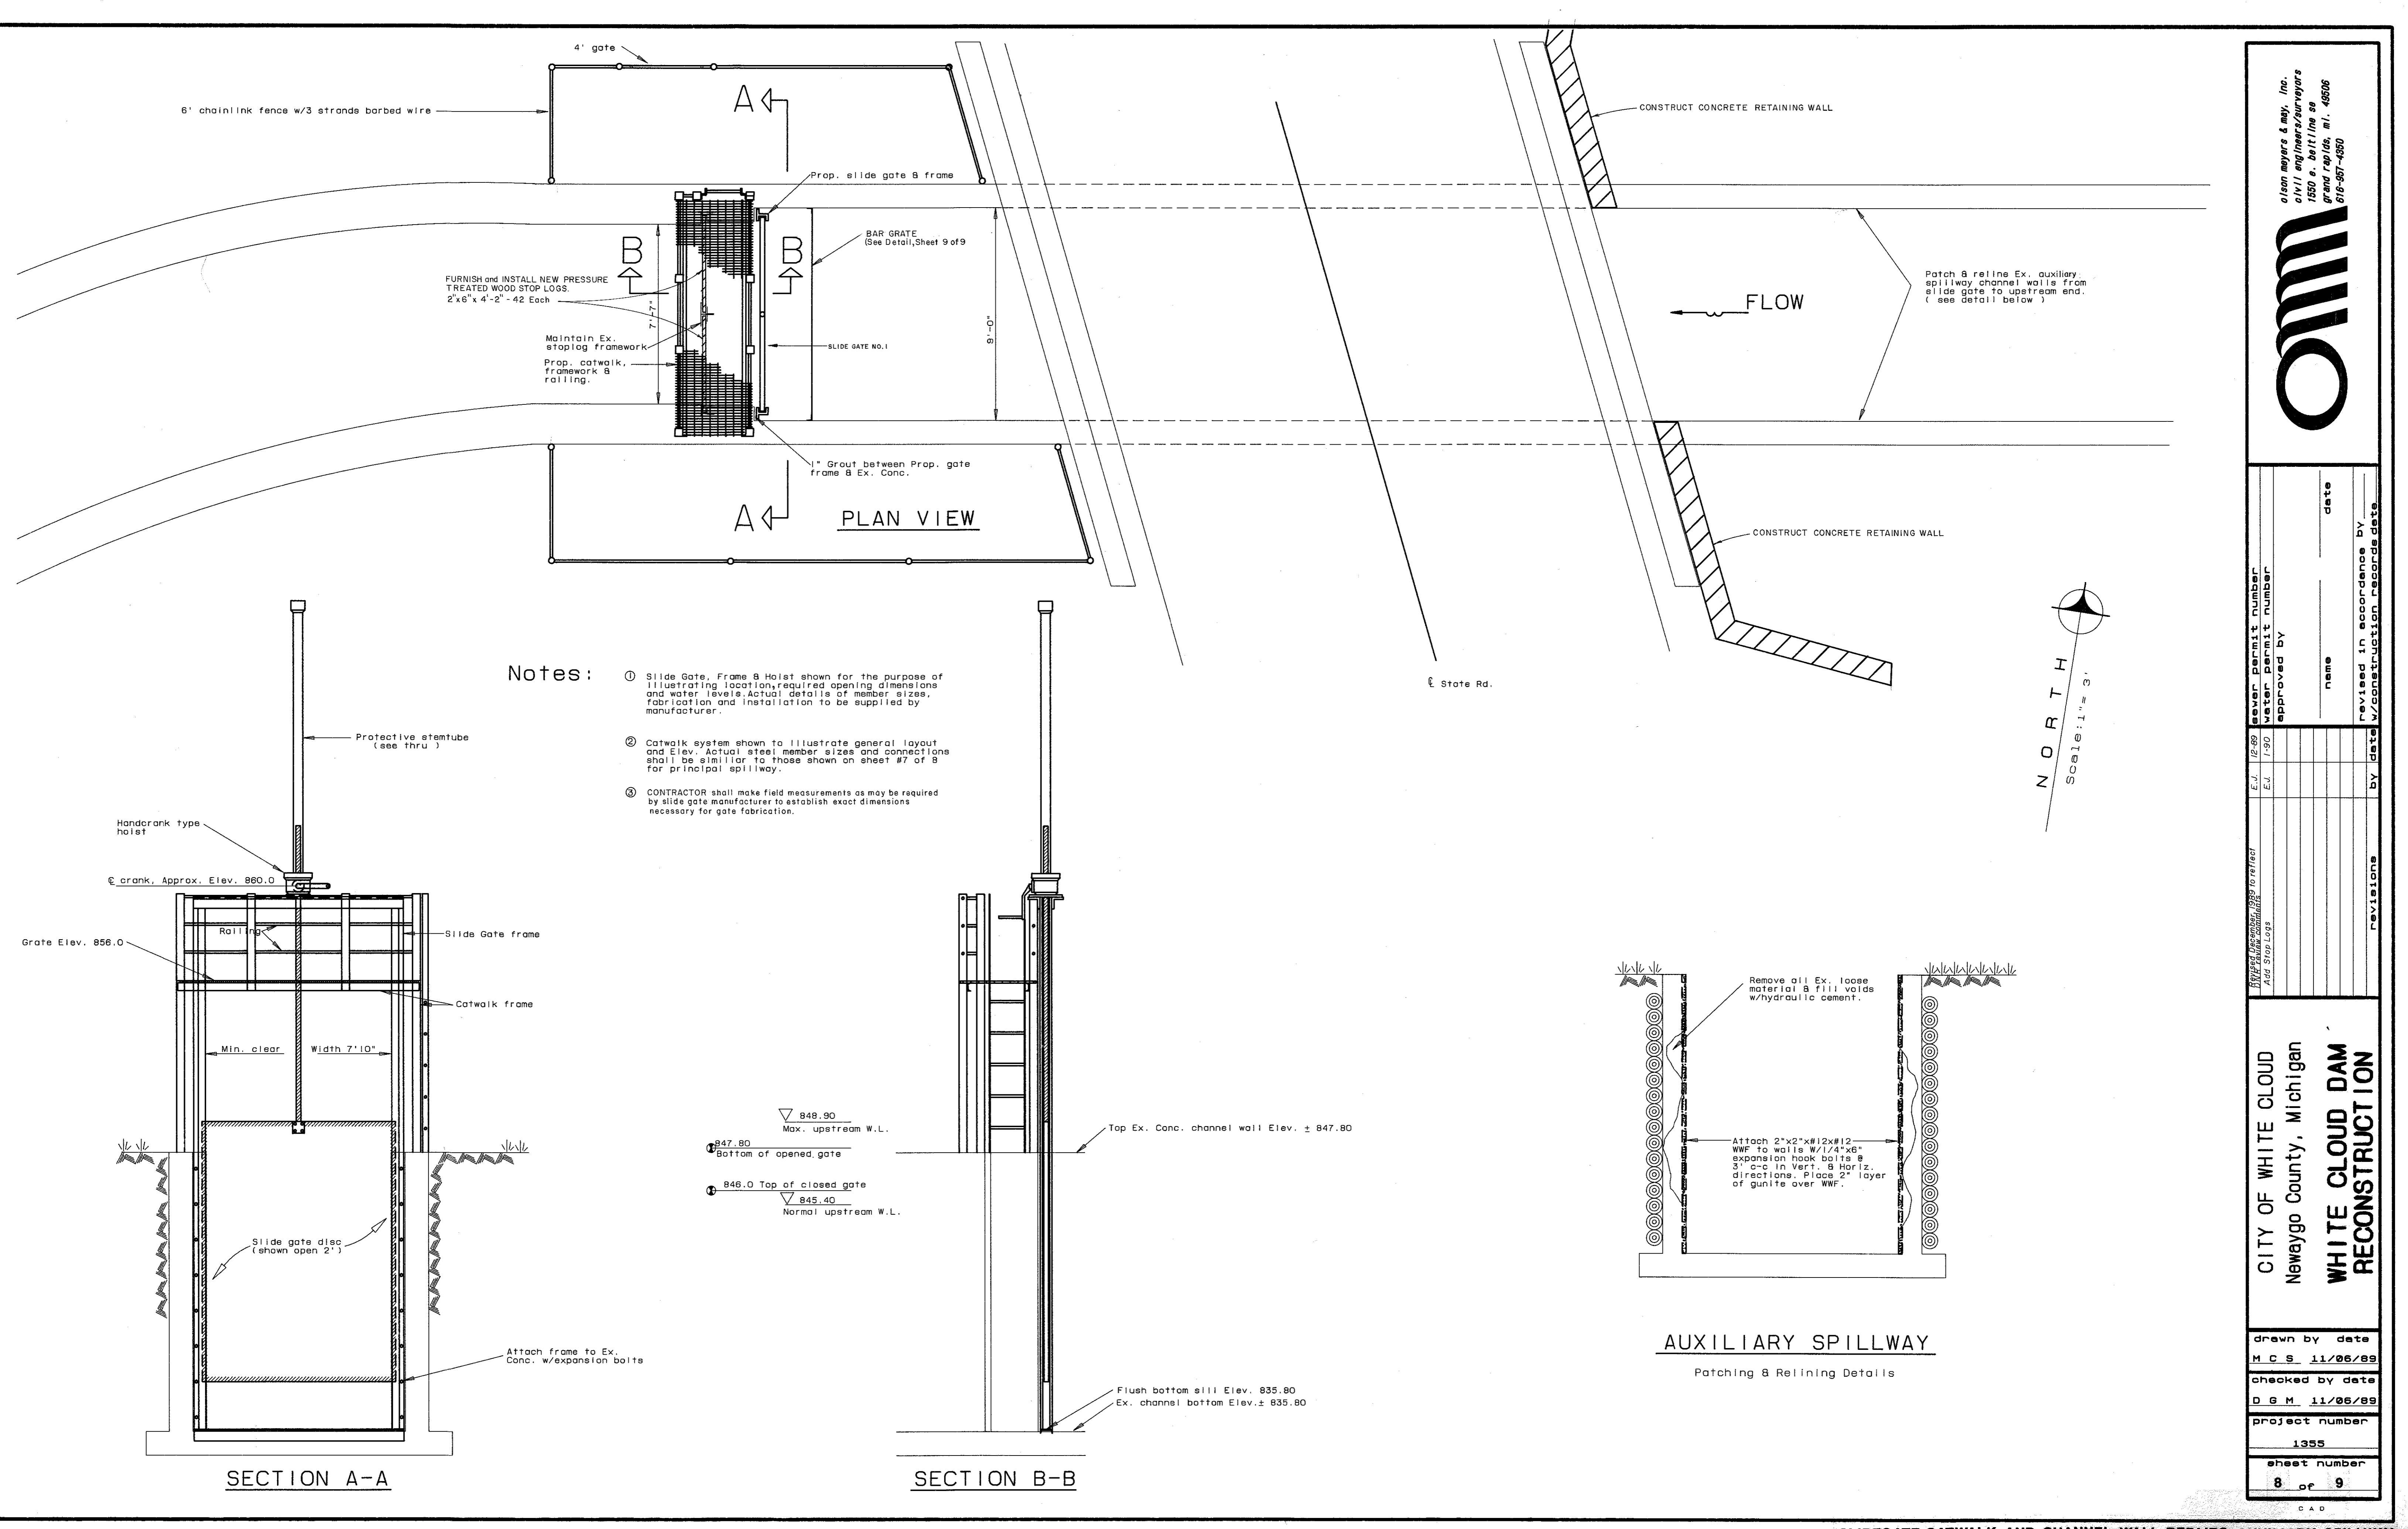
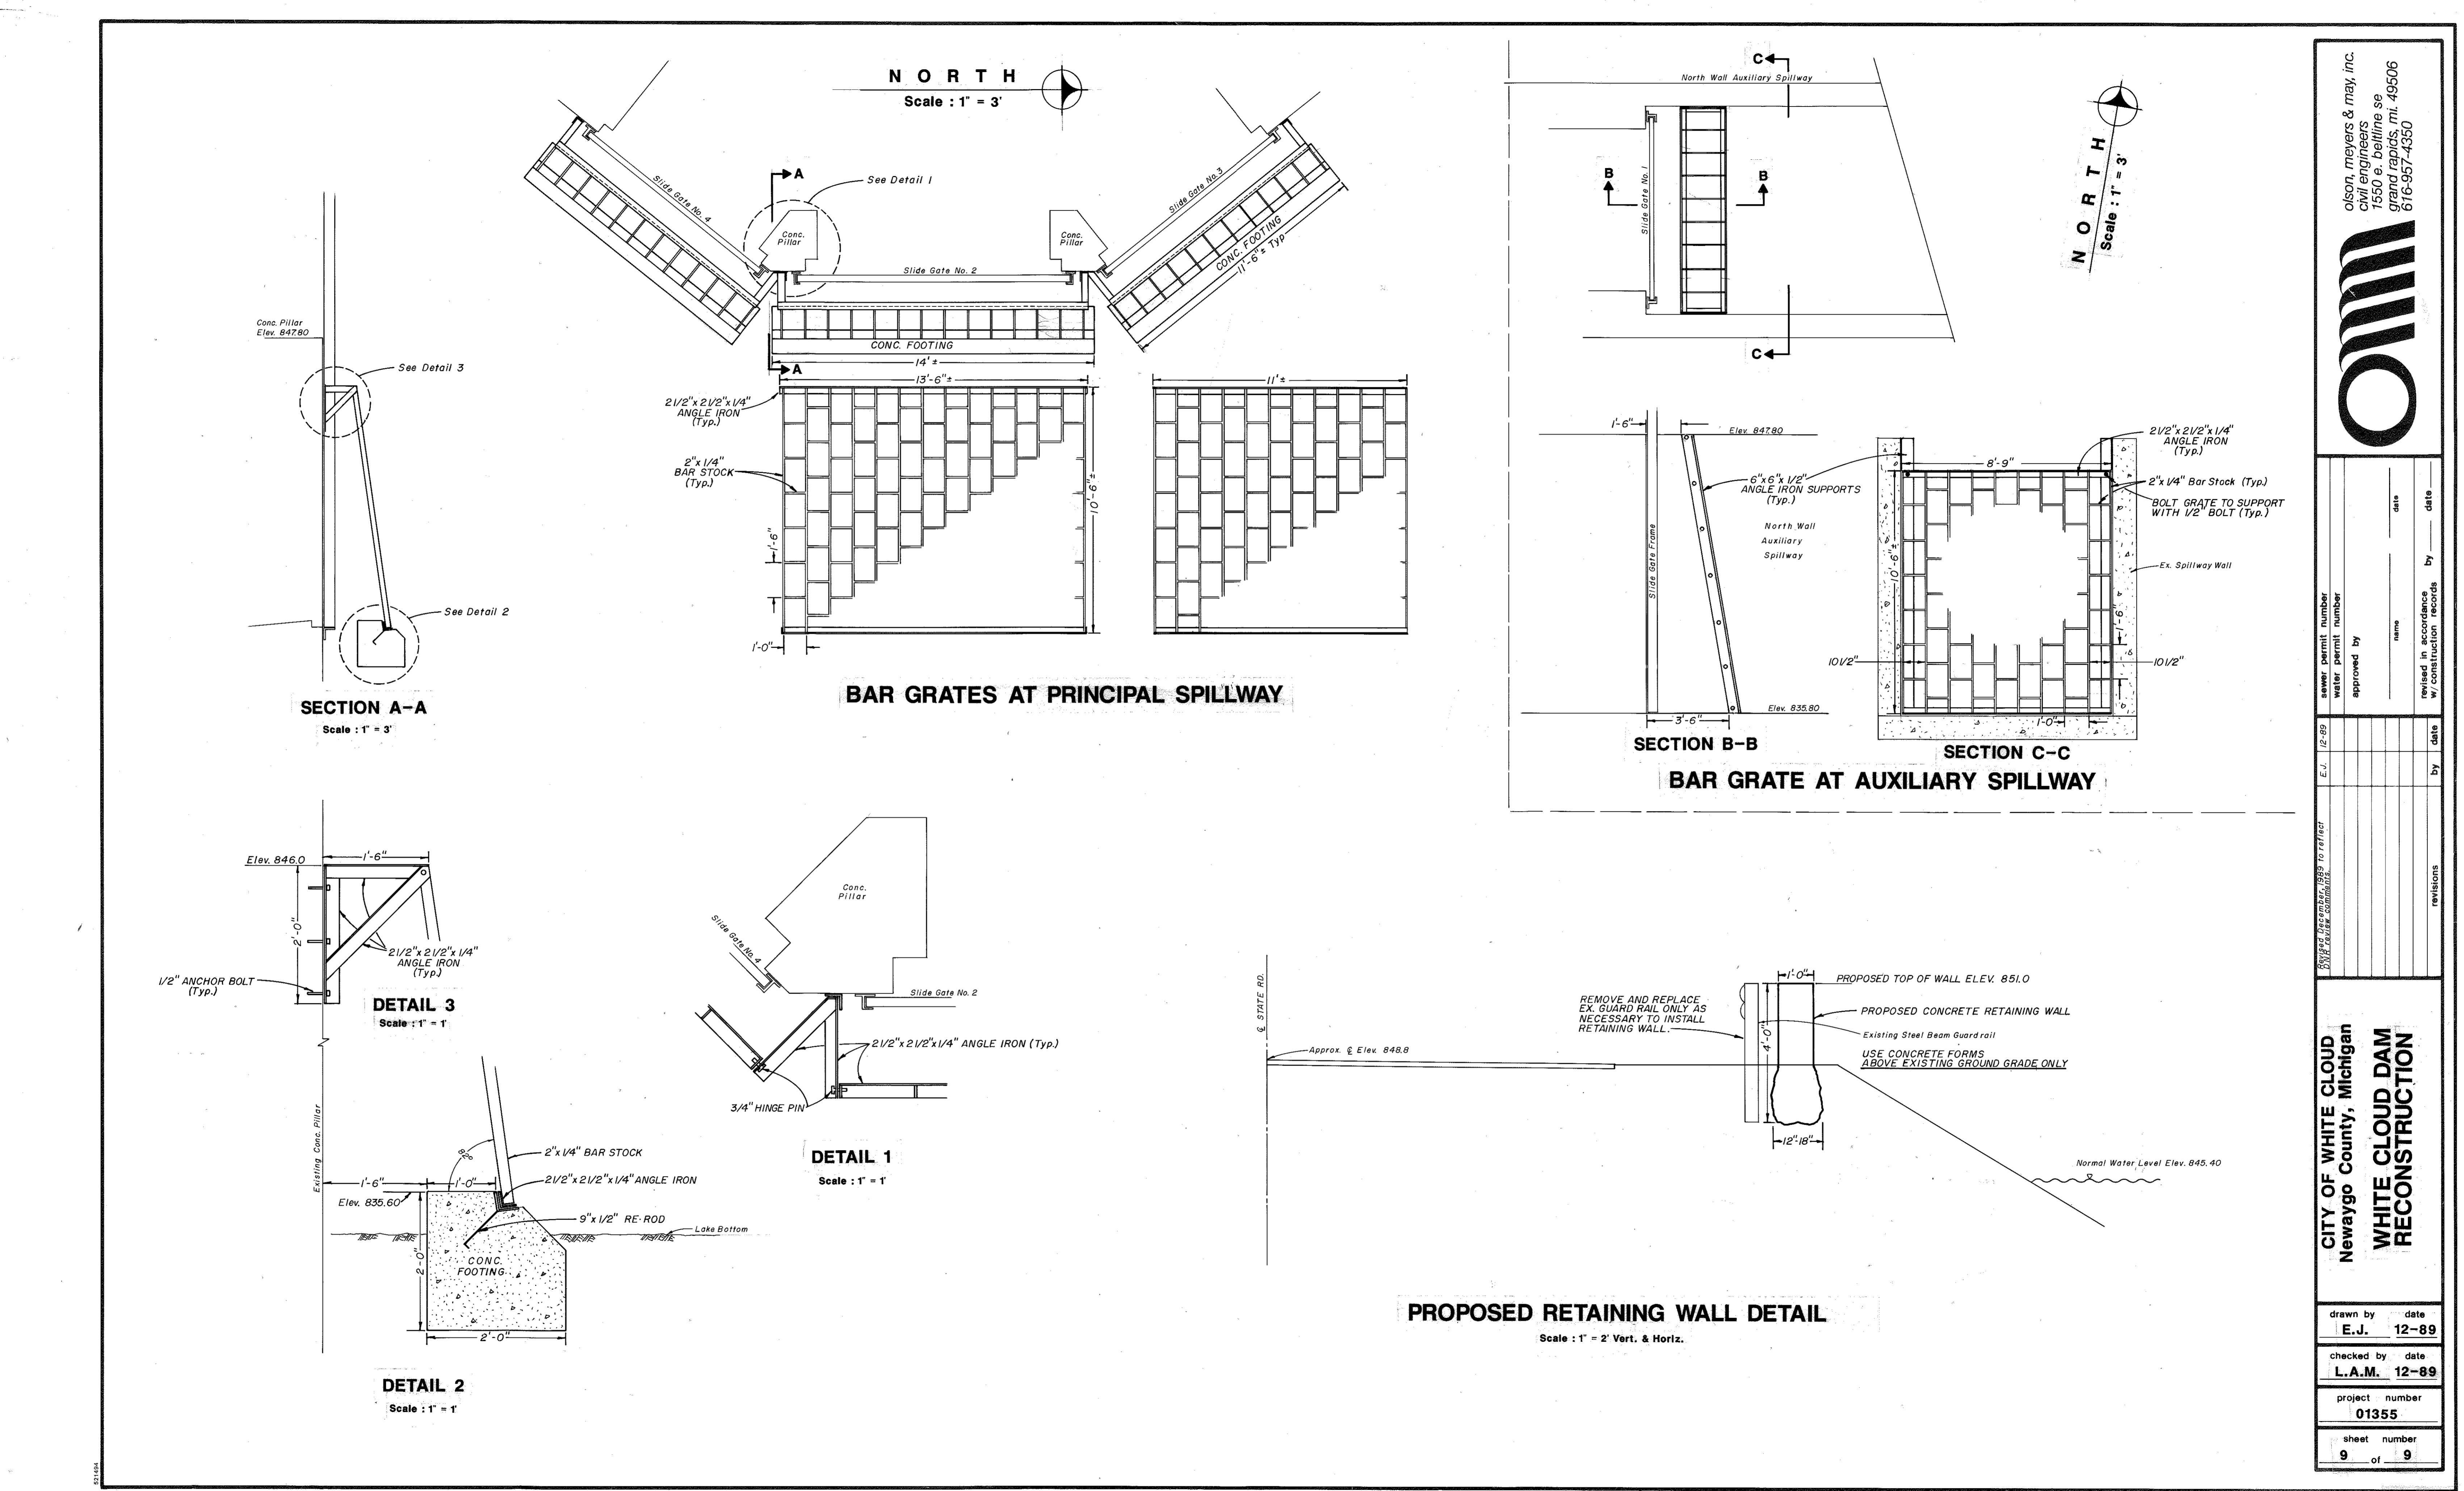
SLIDEGATE, CATWALK AND CHANNEL WALL REPAIRS: AUXILIARY SPILLWAY
