White Cloud Dam Disposition Feasibility Study

White Cloud Dam, White Cloud, Michigan

February 14, 2025 Project 2302435

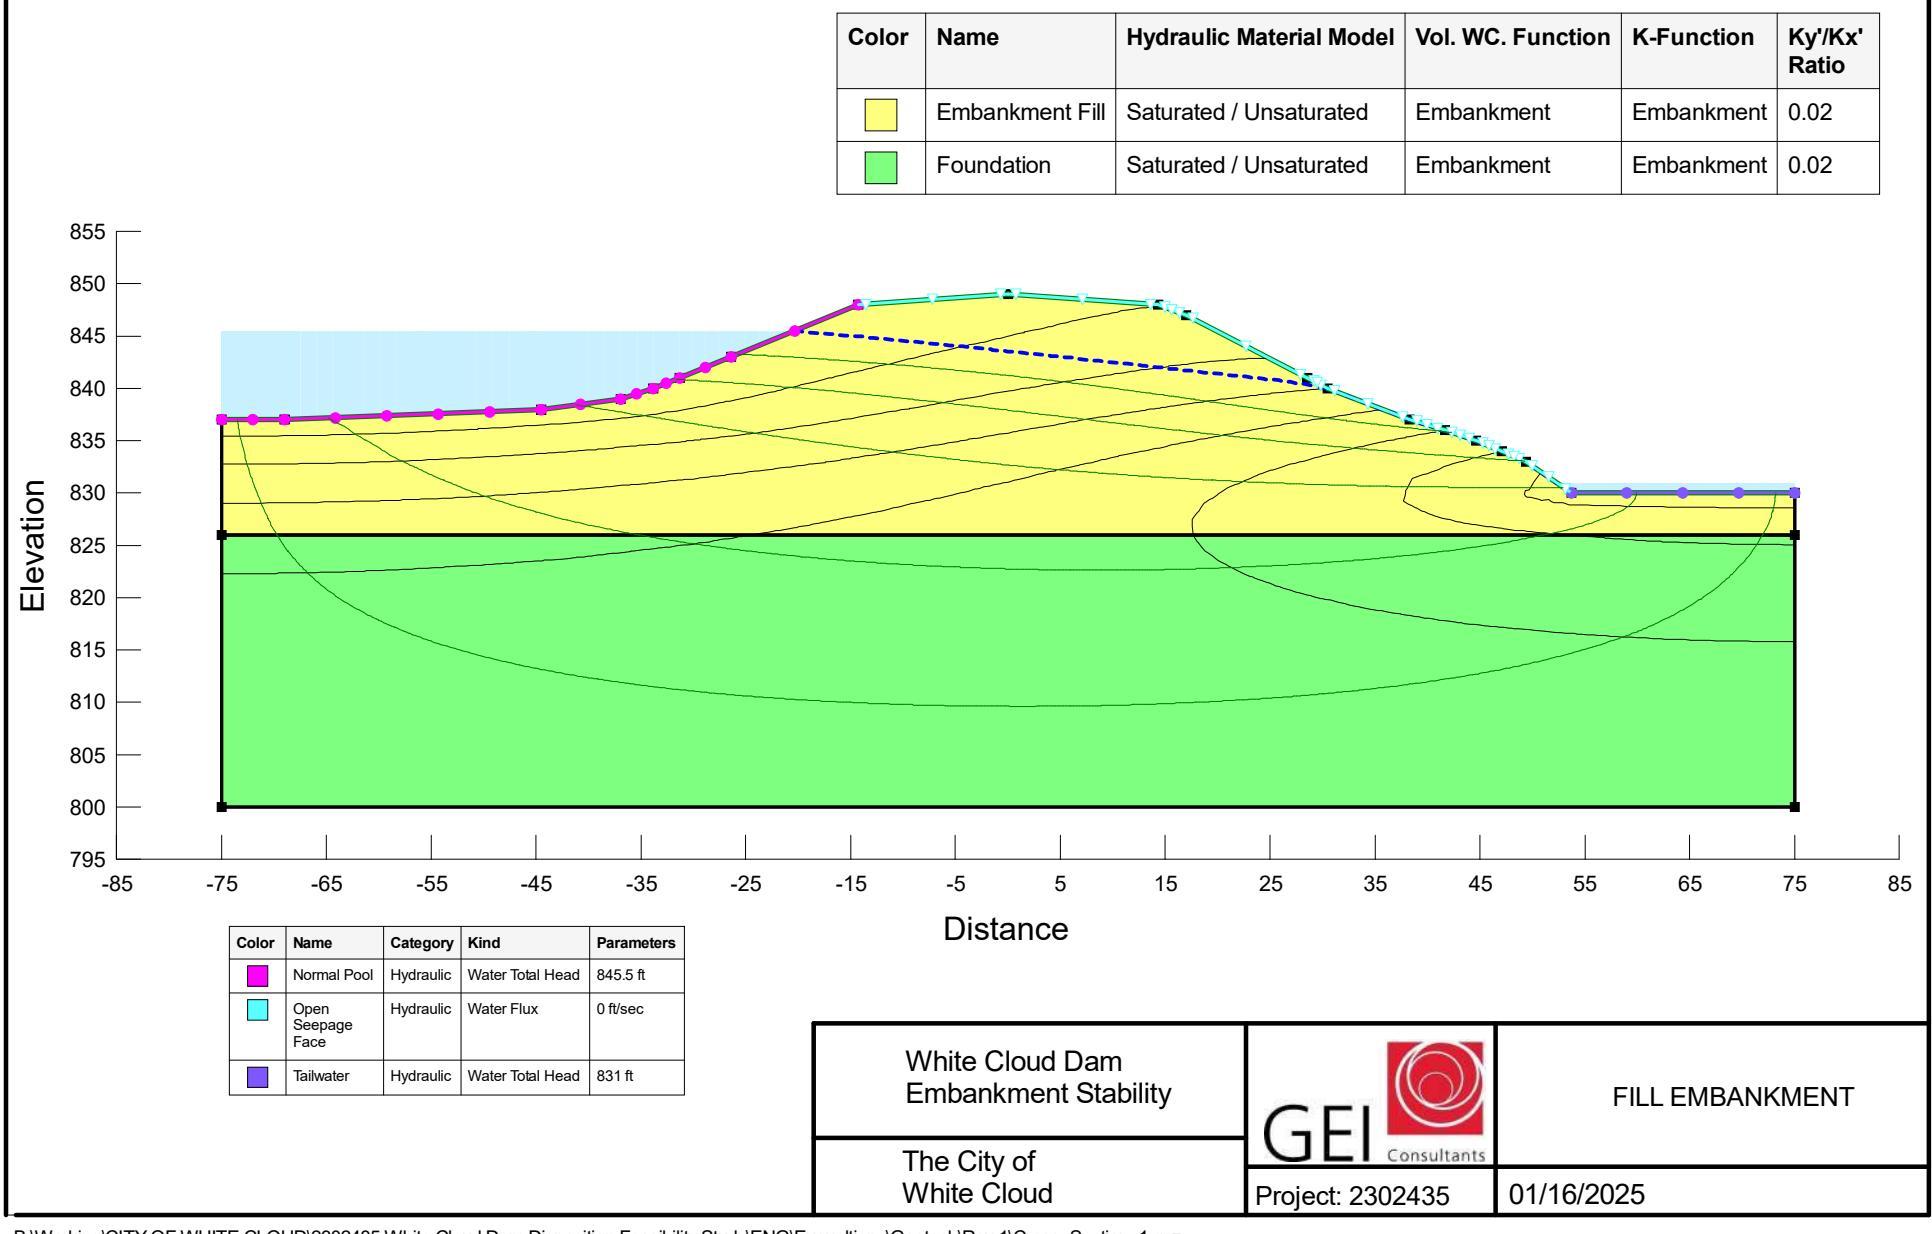
#### ANALYSIS: Steady-State Seepage NP

A SEEP/W model was run on the representative section and calibrated to the existing conditions based on the normal pool headwater elevation and the seepage breakout at the toe of the right earthen embankment. The observed seepage breakout elevation was determined to be approximately at El. 840 feet. Calibration of the model included adjusting the conductivity ratios (Ky/Kx) and adjusting hydraulic conductivities of the defined embankment to most closely match seepage breakout at El. 840 feet that was observed on-site assuming a normal pool headwater elevation. The calibrated seepage model for the existing condition is attached.

# RIGHT EMBANKMENT SECTION REV. 1

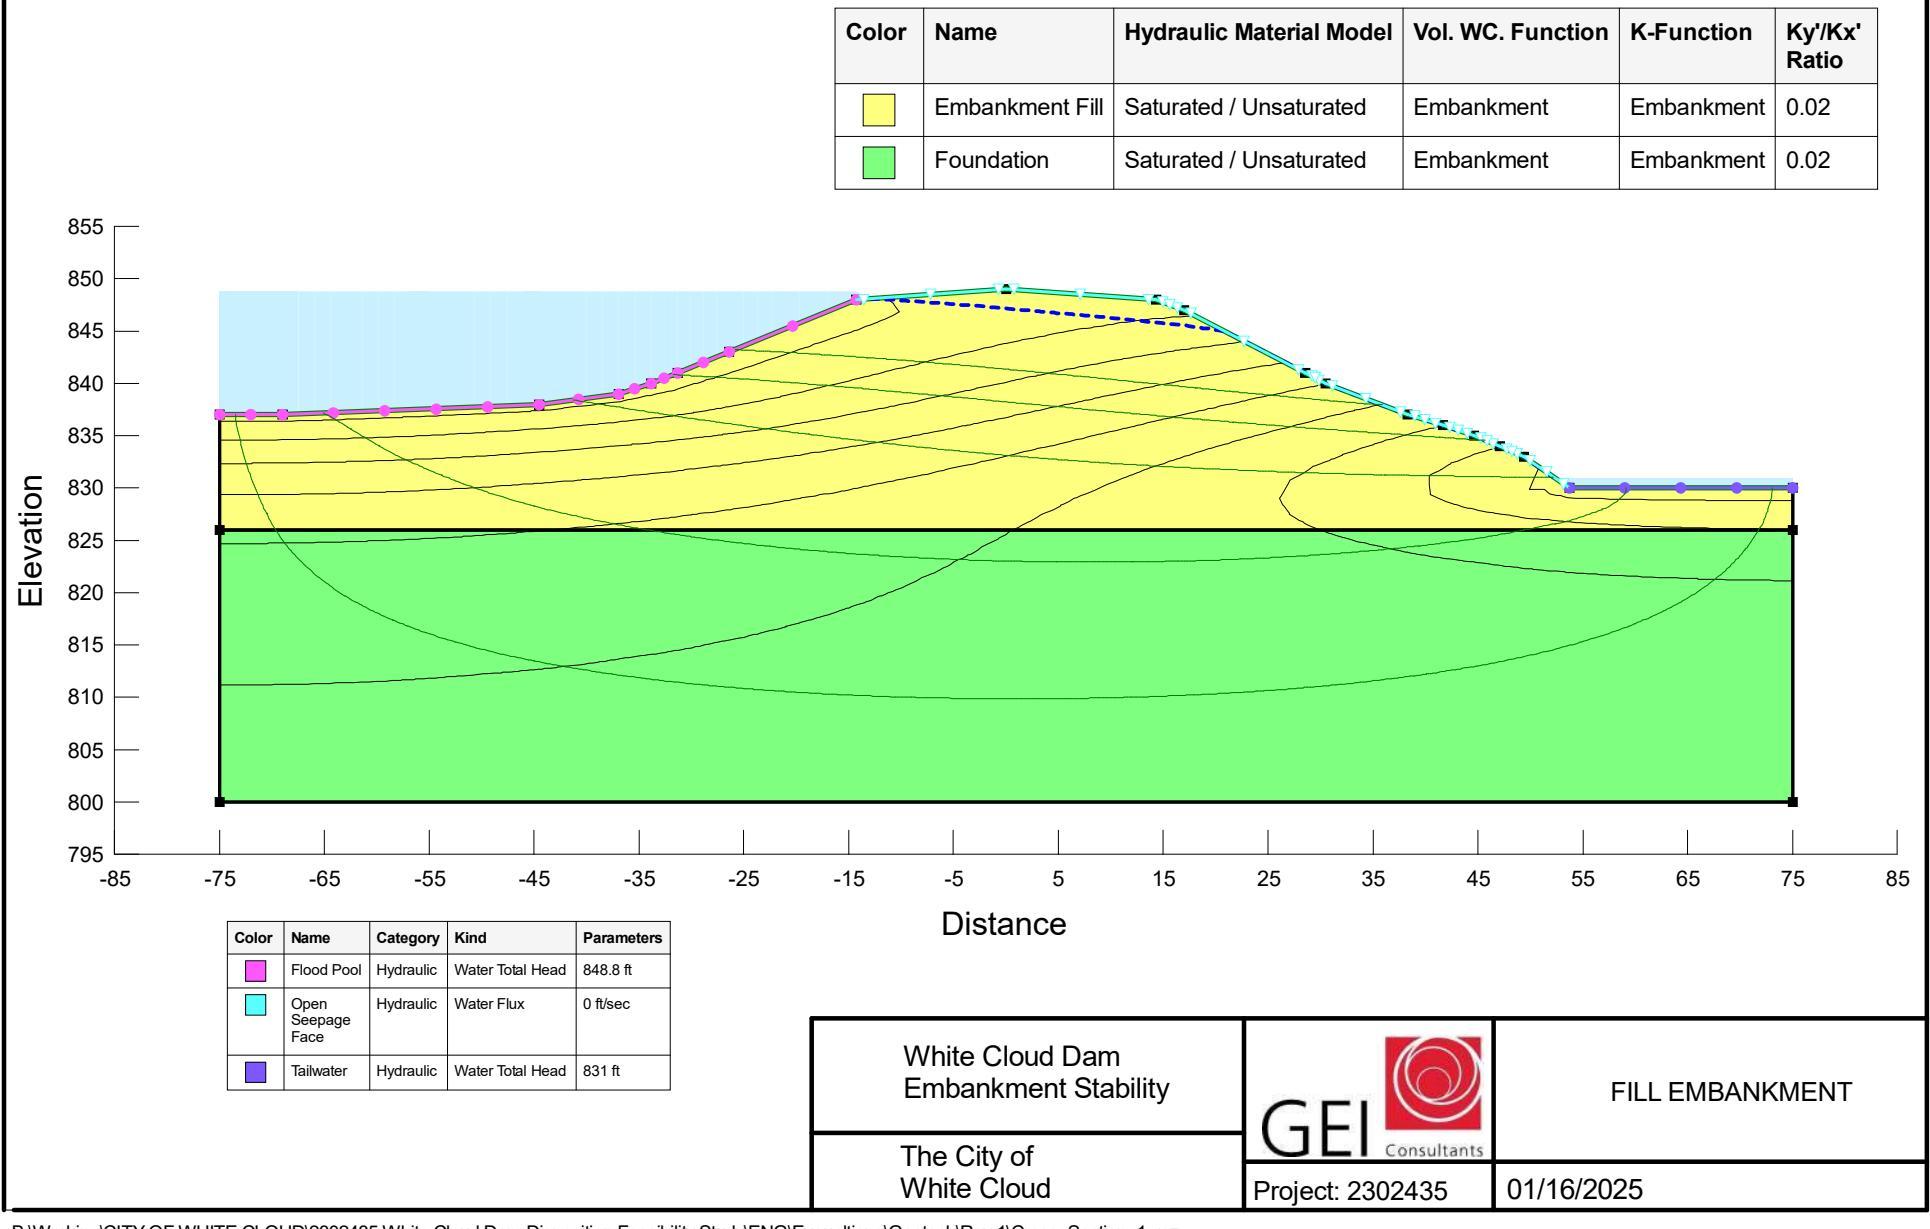
# ANALYSIS: Steady-State Seepage FP

B:\Working\CITY OF WHITE CLOUD\2302435 White Cloud Dam Disposition Feasibility Study\ENG\Evaualtions\Geotech\Rev 1\Cross_Section_1.gsz
# RIGHT EMBANKMENT SECTION REV. 1

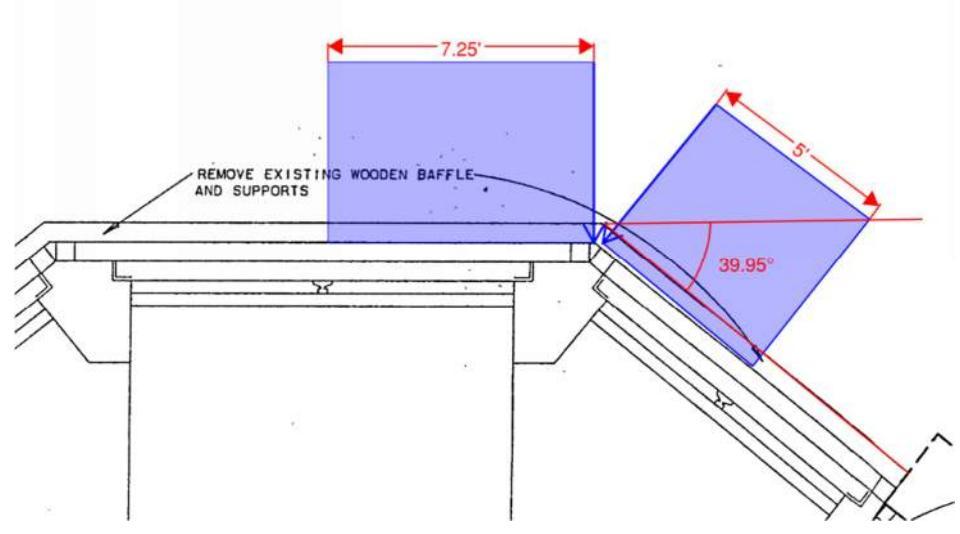
Figure 17 – Hydrostatic Loading of Pier

The principal load considered for the intake piers is the hydrostatic load on the gates / stop logs. Hydrostatic:

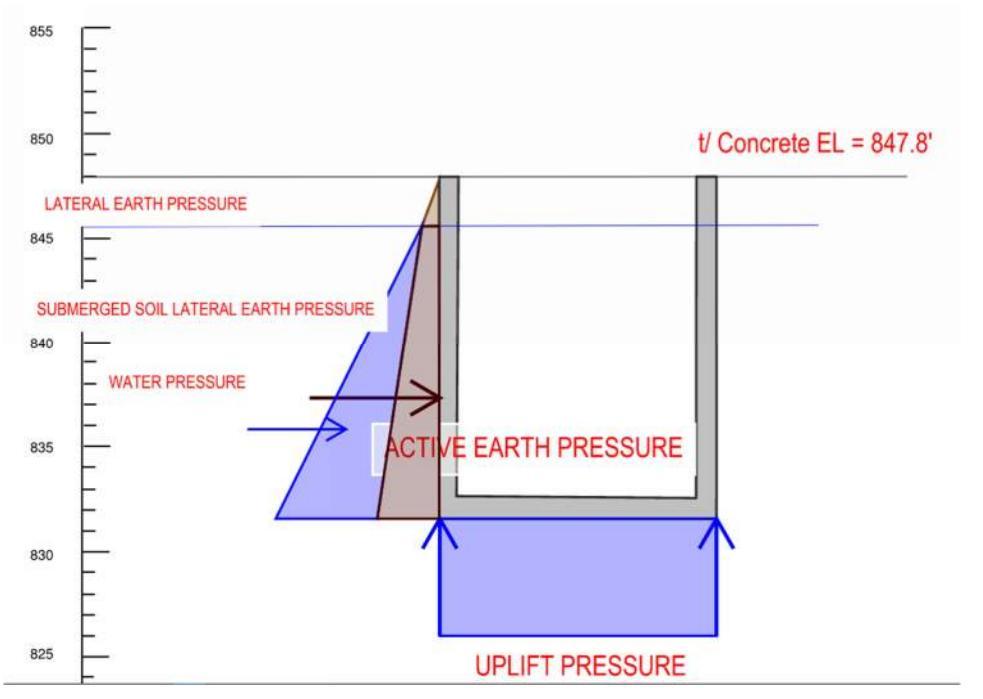
Figure 25 – Active Earth Pressure Chute Wall – Minimum Span

The shortest Unsupported span in the chute wall occurs immediately downstream of the bridge crossing. The unsupported height in this location is 60" it was assumed that saturated soil conditions exist up to the top of the wall in this section.

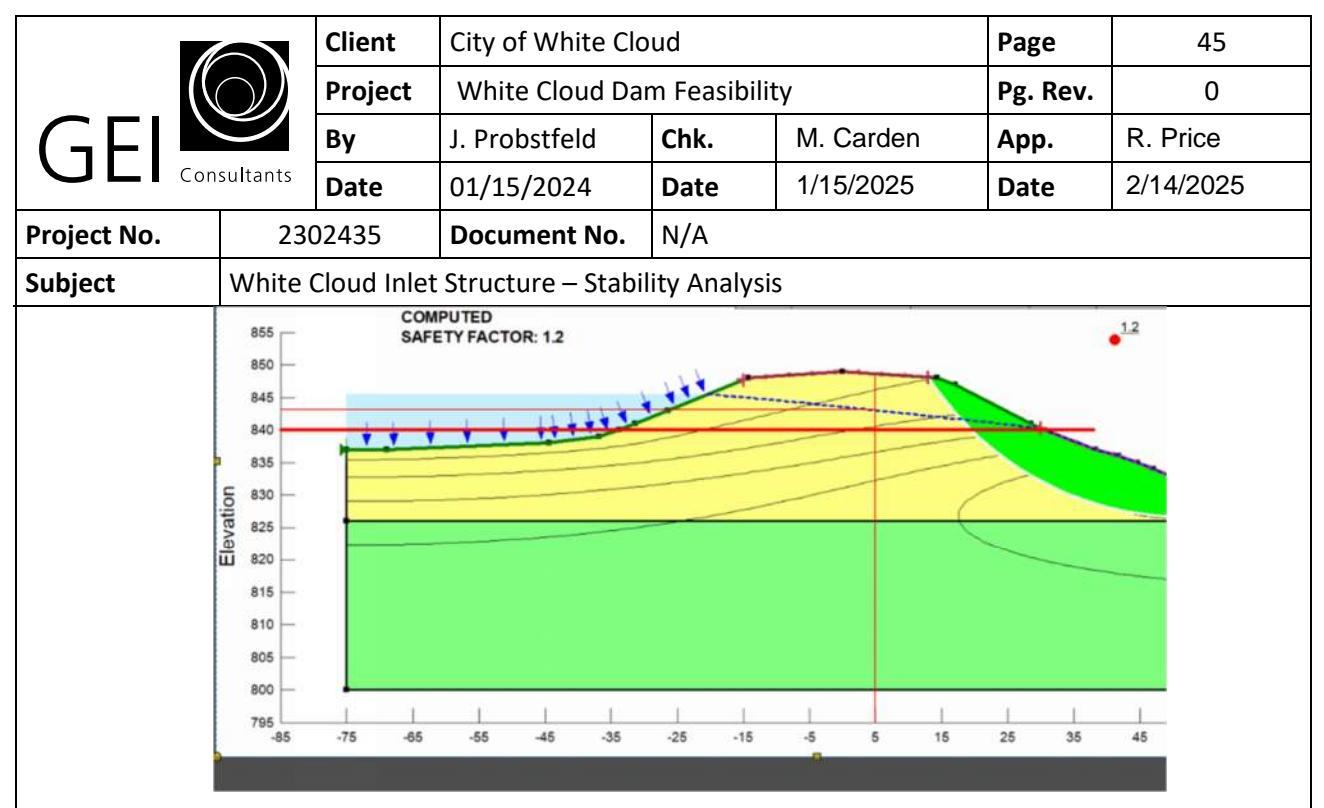
Figure 26 – Water Table Estimate – Slope Stability Analysis

Height of retained soil :	H _{soil.chute} = 184 in
Water Table Elevation:	El _{water.table} = 840 ft
Top of Slab Elevation:	$EI_{t.slab.chute} = EI_{twall} - H_{soil.chute} = 832.47 \text{ ft}$
Height of Submerged Soil:	$H_{soil.chute.sub} = EI_{water.table} - EI_{t.slab.chute} = \textbf{7.53} \text{ ft}$
Height of Moist Soil:	$H_{soil.saturated} = EI_{twall} - EI_{water.table} = 7.80 \text{ ft}$
