# White Cloud Dam Removal Preliminary Analysis

Prepared by Trout Unlimited

This report was developed by Trout Unlimited (TU), with input from the City of White Cloud, to serve as a resource for the White Cloud City Council as they evaluate options regarding the White Cloud Dam. The City of White Cloud is faced with the decision of whether to continue investing in ongoing maintenance and repairs for the dam or pursue other options, such as removal of the dam. This report is designed to provide a preliminary understanding of the dam removal option. It is not a complete engineering and feasibility study that would help determine how the dam should be removed but is meant to help inform the decision of whether to pursue dam removal. This report provides an overview of the history, background and status of the White Cloud Dam and White Cloud Pond. Additionally, this report provides an overview of the dam removal process including several case studies, important factors and considerations for removal of the White Cloud Dam, potential results and outcomes of dam removal and options for dam removal funding and support.

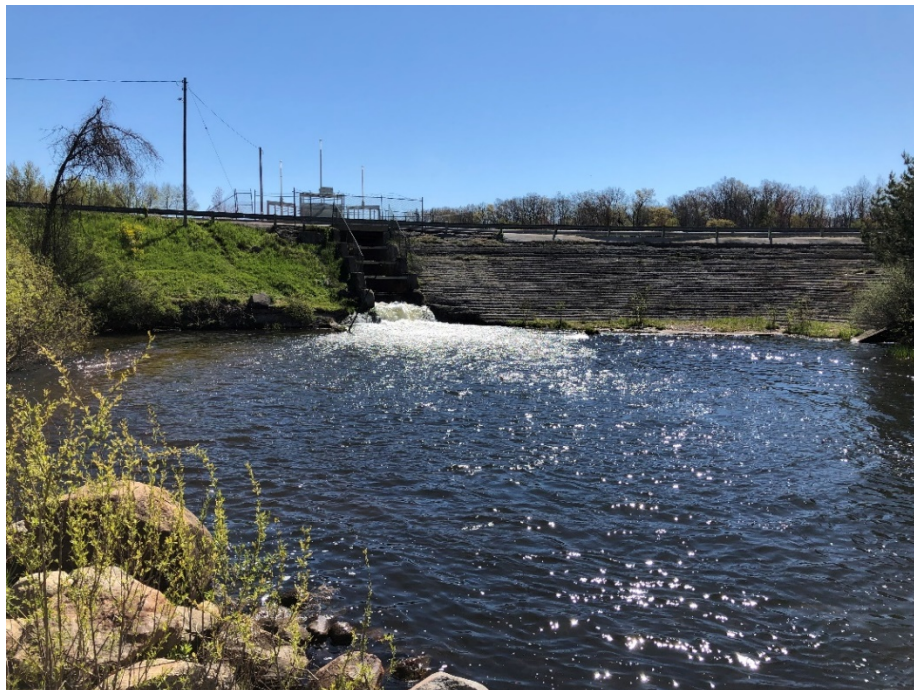
*Figure 1: White Cloud dam spillway and embankment.*

The White Cloud Dam is a 950-foot long embankment with three gated concrete spillways (Figure 1). On the south side of the dam the embankment is constructed of concrete and is slightly lower than the earthen embankment on the north side of the dam, creating a 140-foot long overflow spillway, designed to allow water to flow over the top of the dam during high flow conditions (Figure 2). There is an auxiliary gated spillway at the north end of the dam, designed to serve as an additional water release point (Figure 3).

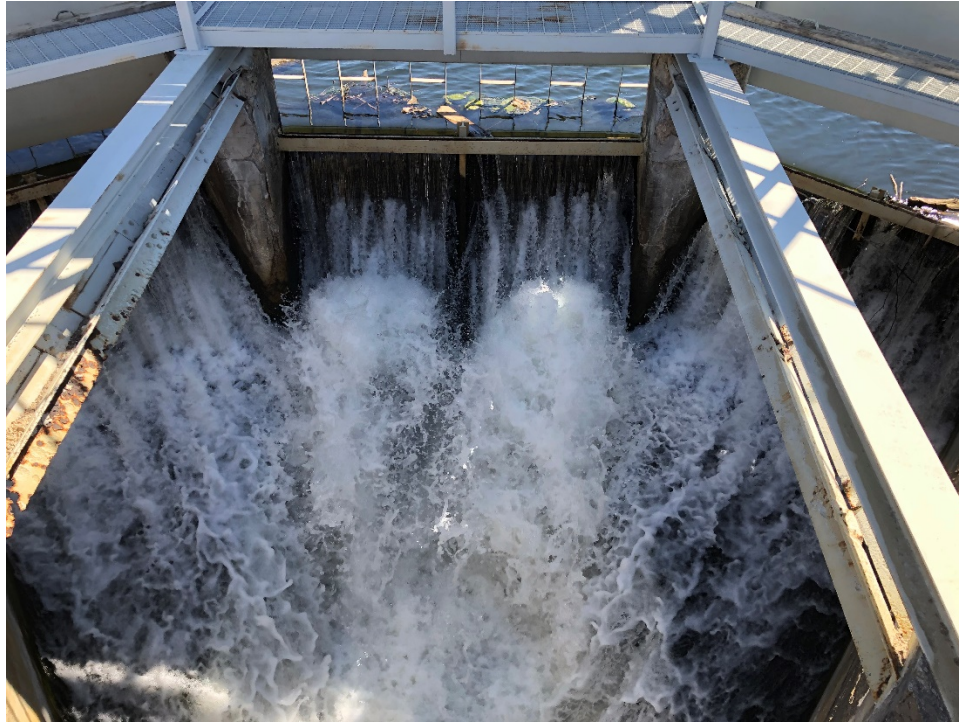
*Figure 2: Spillway gate.*

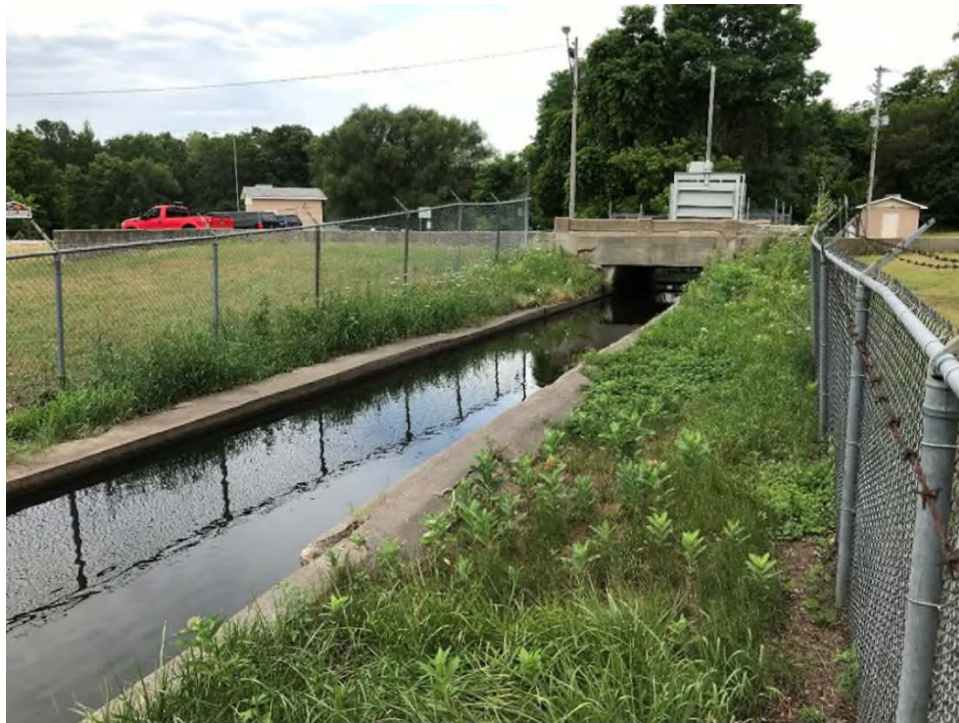
*Figure 3: Auxiliary spillway intake channel. Photo; EGLE.*

auxiliary spillway was installed. The dam failed a second time in 1986 during a flood event and was rebuilt in 1990, adding the overflow spillway (Devaun 2019).

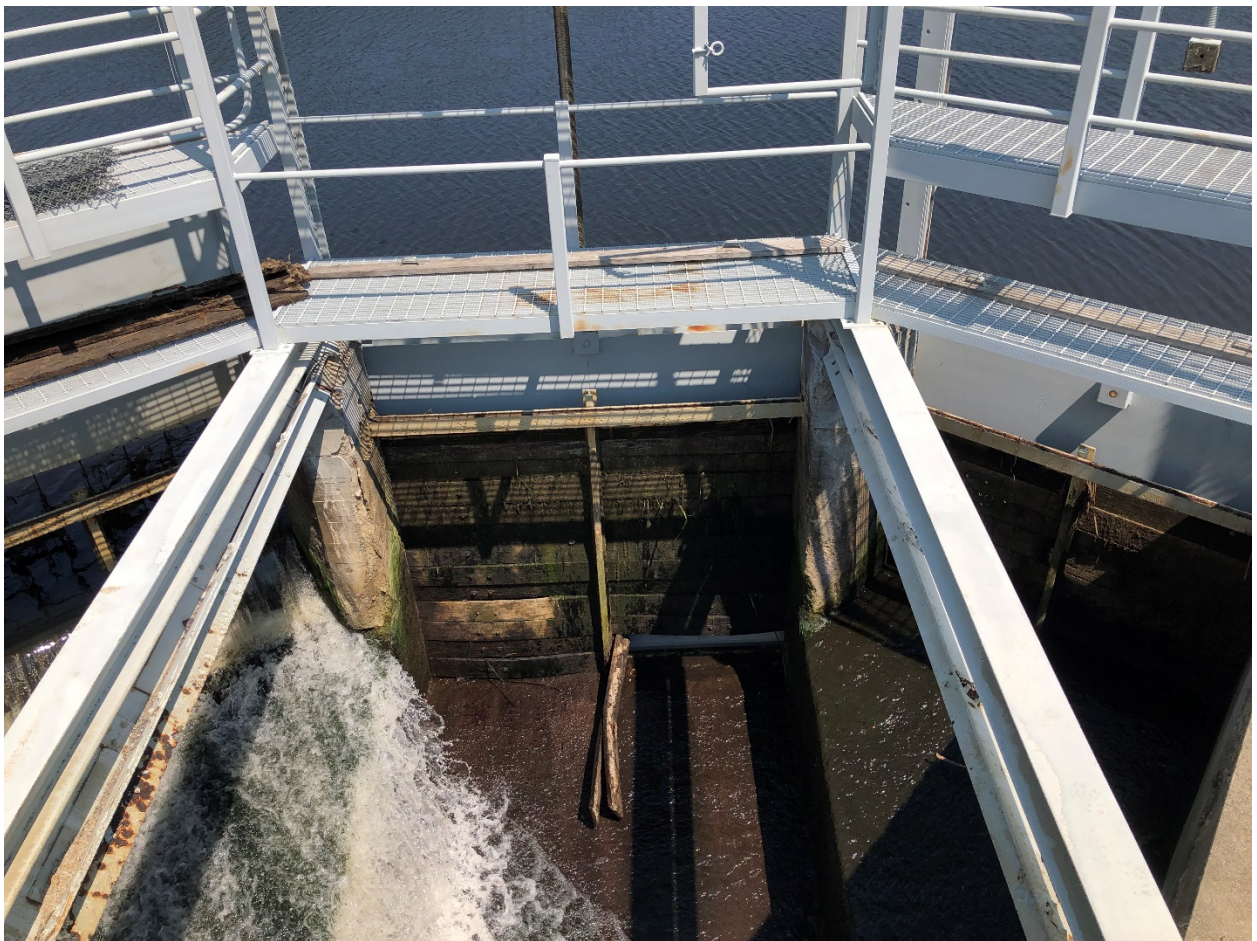
*Figure 7: Stoplog failure in July 2021.*

Stoplogs are used to adjust the water level in White Cloud Pond. When the dam gates are open, the stop logs impound the water, allowing water to spill over the top to maintain the specified water level in the pond. In July of 2021, two stoplogs failed at the primary spillway, causing White Cloud Pond to drop by approximately 10 feet (Figure 7). This issue was not identified in the previous inspection report. Not all parts of the dam are readily observable, and even with regular inspections, unforeseen issues can arise requiring additional resources and increased liability. All the stoplogs were subsequently replaced at a cost of \$650.

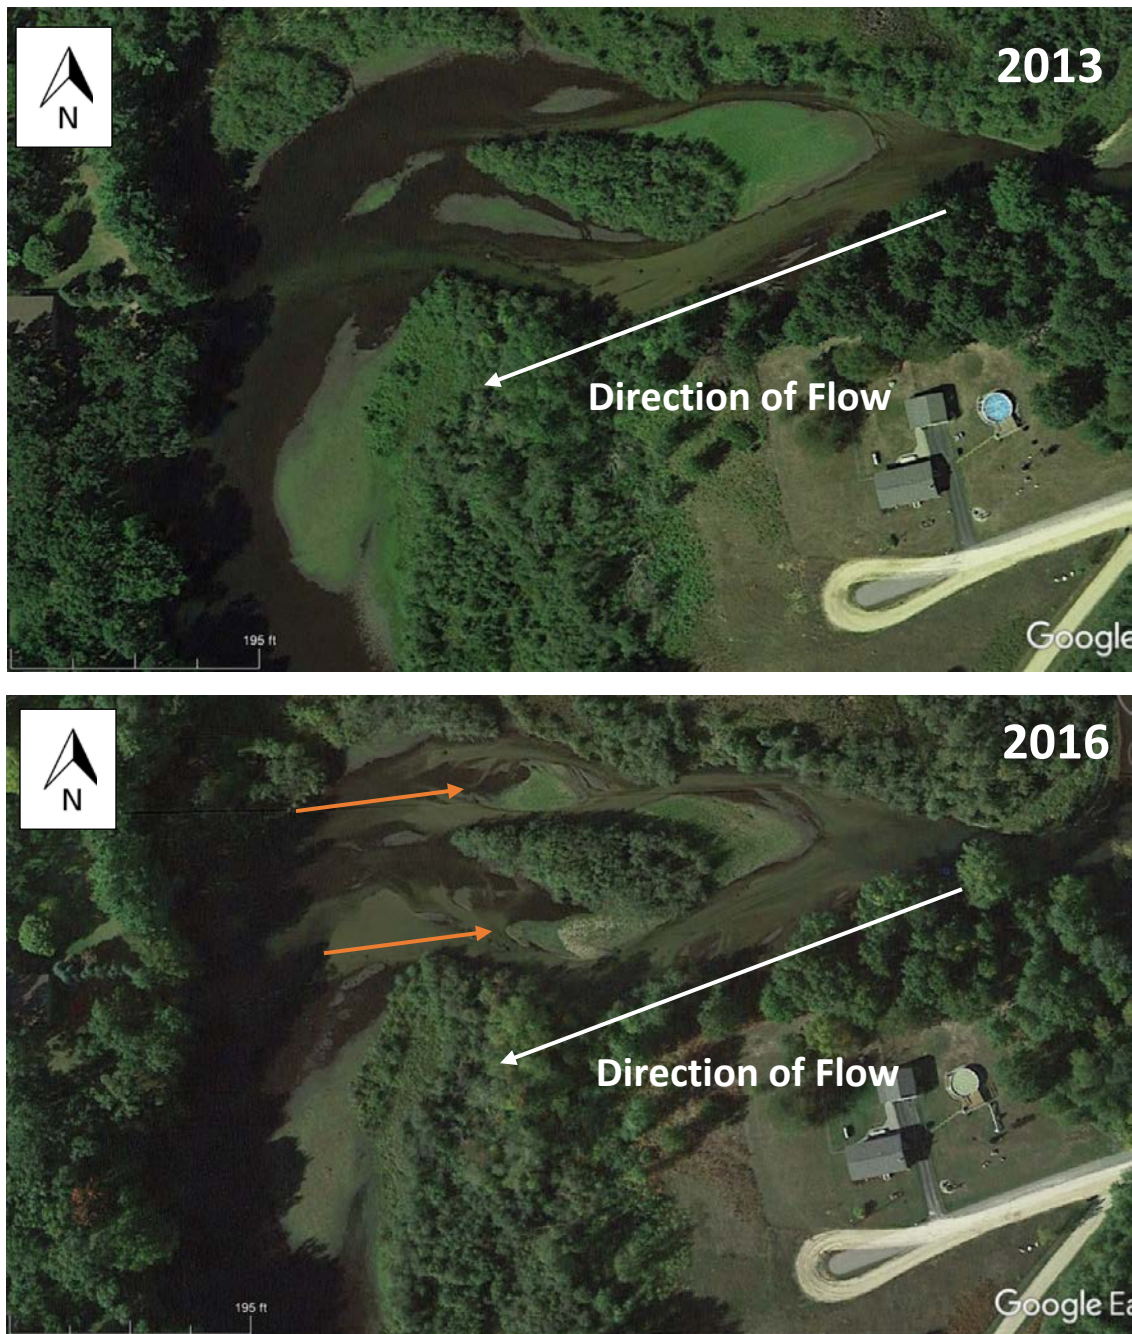
*Figure 9: Aerial images of the uppermost portion of the White Cloud Impoundment indicates increased sedimentation between 2013 and 2016. Red arrows indicate areas showing increased sedimentation. This site is located just downstream of the M20 bridge.*

Dams not only impede the flow of water, they also impede the flow of sediment. Streams and rivers pick up sediment, carry it downstream and eventually deposit it. When a river is impounded, the velocity, or speed, of the water decreases causing sediment suspended in the water to settle to the bottom of the impoundment. Over time, continued deposition of sediment has begun to fill the White Cloud dam reservoir, reducing the depth and overall water storage. In time, it is likely that the pond will become completely filled with sediment.

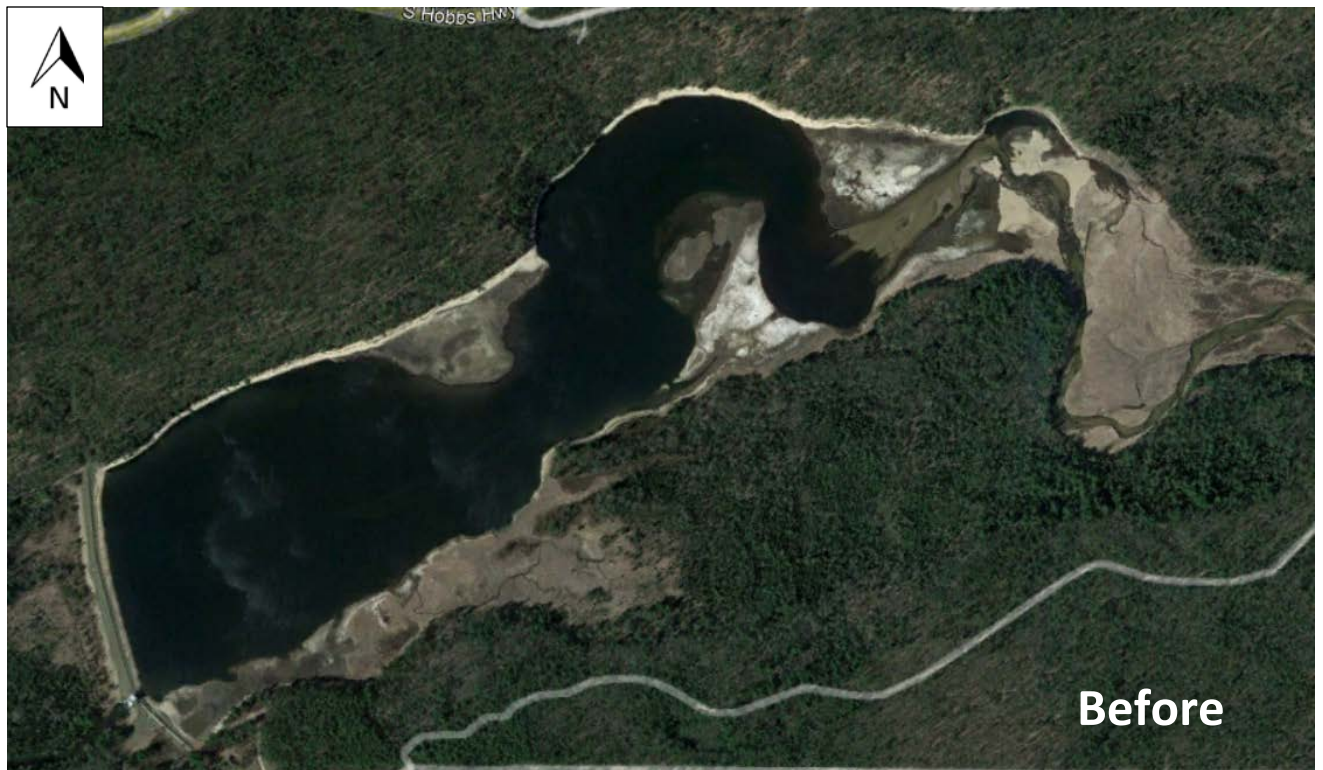
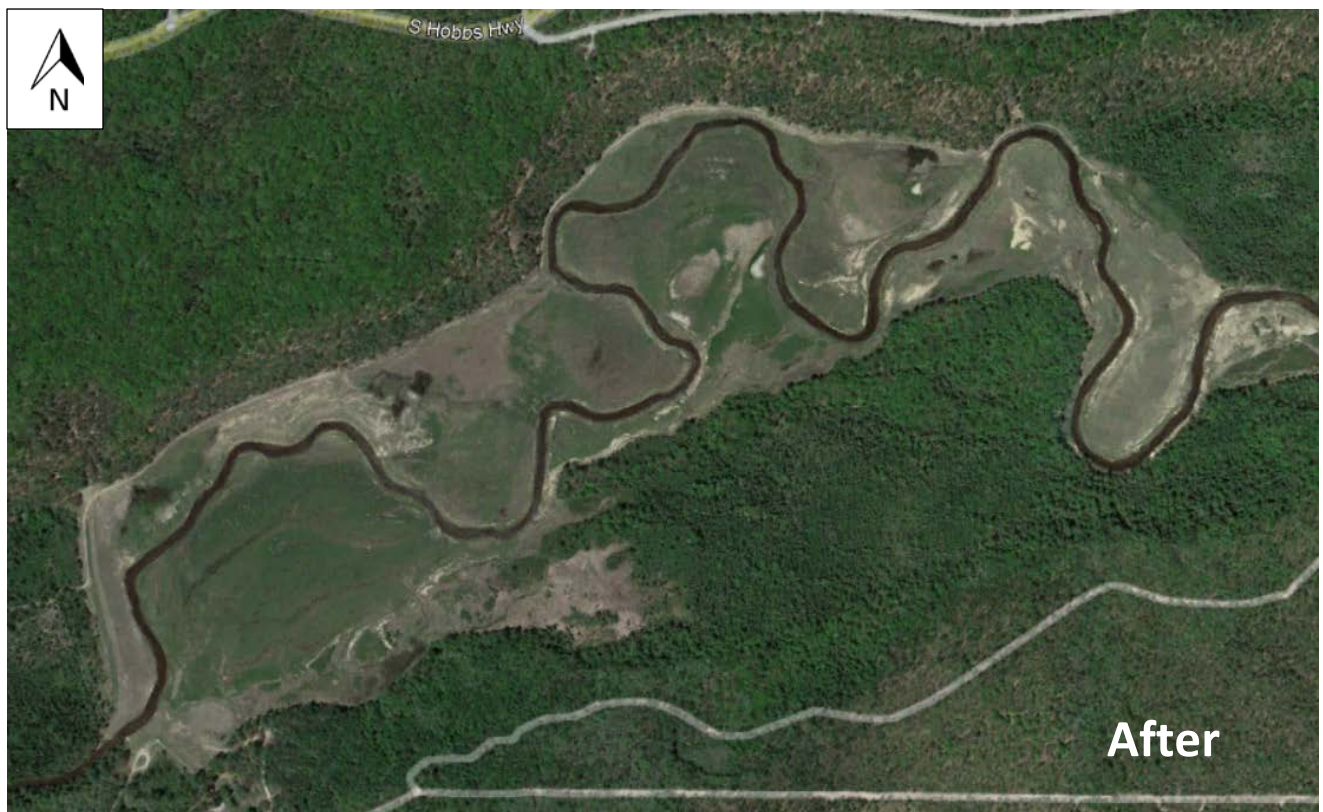
*Figure 12: Aerial image of Boardman River before/after removal of the Brown Bridge Dam.*

In this case, the former impoundment area will turn into a flowing stream section, with wide prairie-like settings surrounding it where the impoundment had flooded. However, individual landowners of the exposed impoundment bottomlands can often decide how they will manage that property. Some owners may choose to actively mow the property and manage it as added lawn; others may choose to let a natural grassland like area develop and maintain it by cutting tree growth; and others may help a forested vegetation takeover by planting trees of their choosing or allowing natural trees to grow. Figures 12 and 13 show two Michigan rivers before and after dam removal. Before/after images show the transition from an impoundment to a river. More aerial images of dam removal sites can be found in Appendix A.

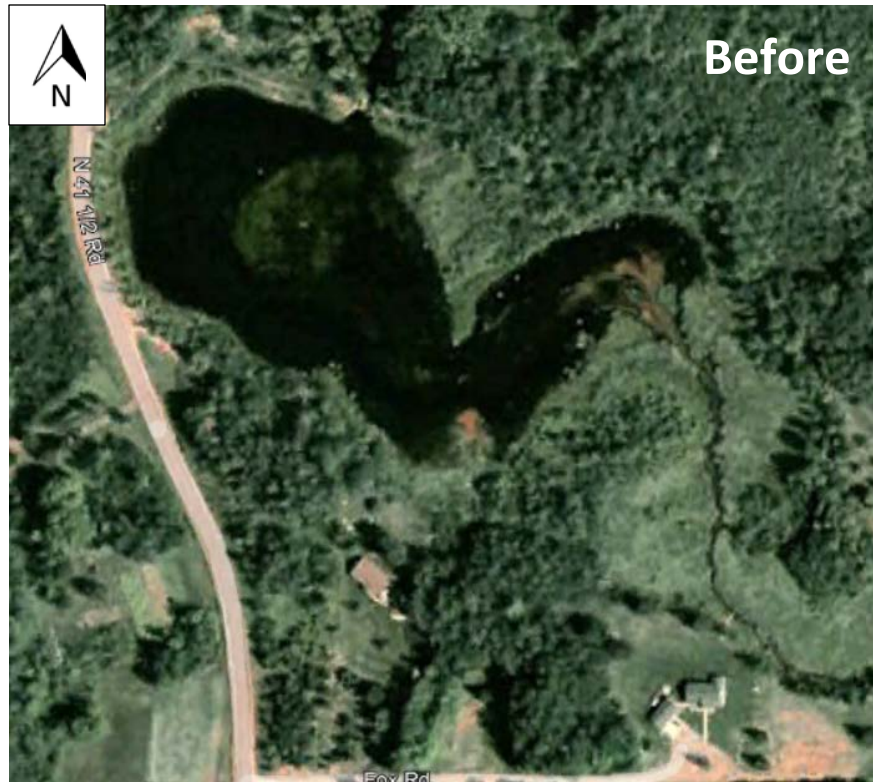
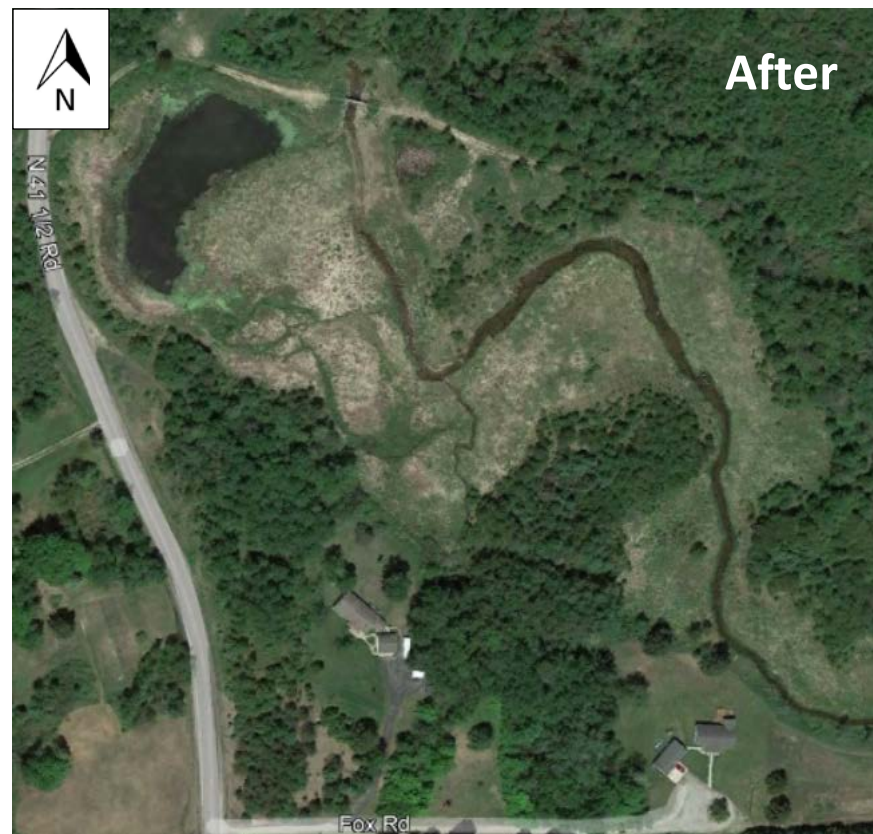
Figure 13: Aerial image of Manton Creek before/after removal of Mill Pond Dam.

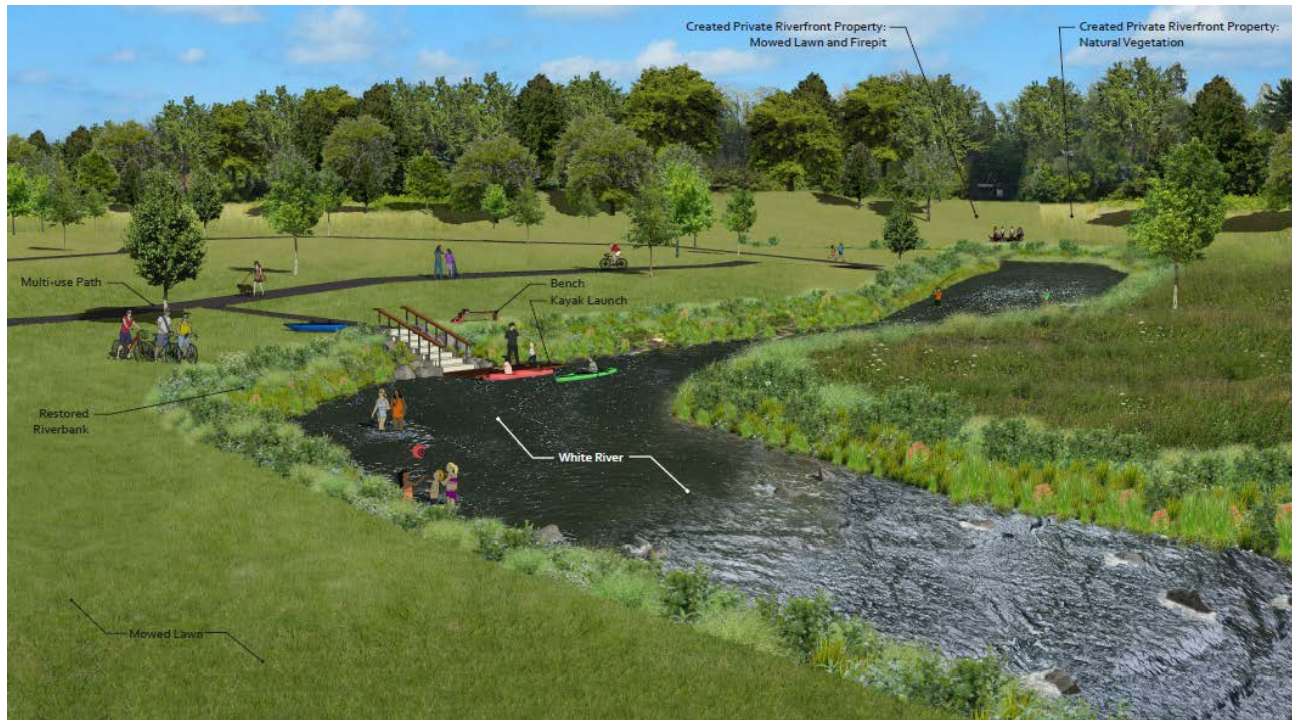
*Figure 15: View from current White Cloud Dam site, looking southeast.*

At the conclusion of dam removal and restoration the site will look quite different. Where there was a small pond, a river would flow. The size of the river will be comparable to nearby upstream and downstream reaches. The river will follow the old river channel, meandering through the area once inundated by the pond. The adjacent, newly exposed, land surface will be managed according to the wishes of landowners. The renderings below were developed to aid the community of White Cloud in visualizing what the site could look like post-dam removal. It is important to note that this is a conceptual rendering, and the actual site outcomes for the newly exposed lands would be determined

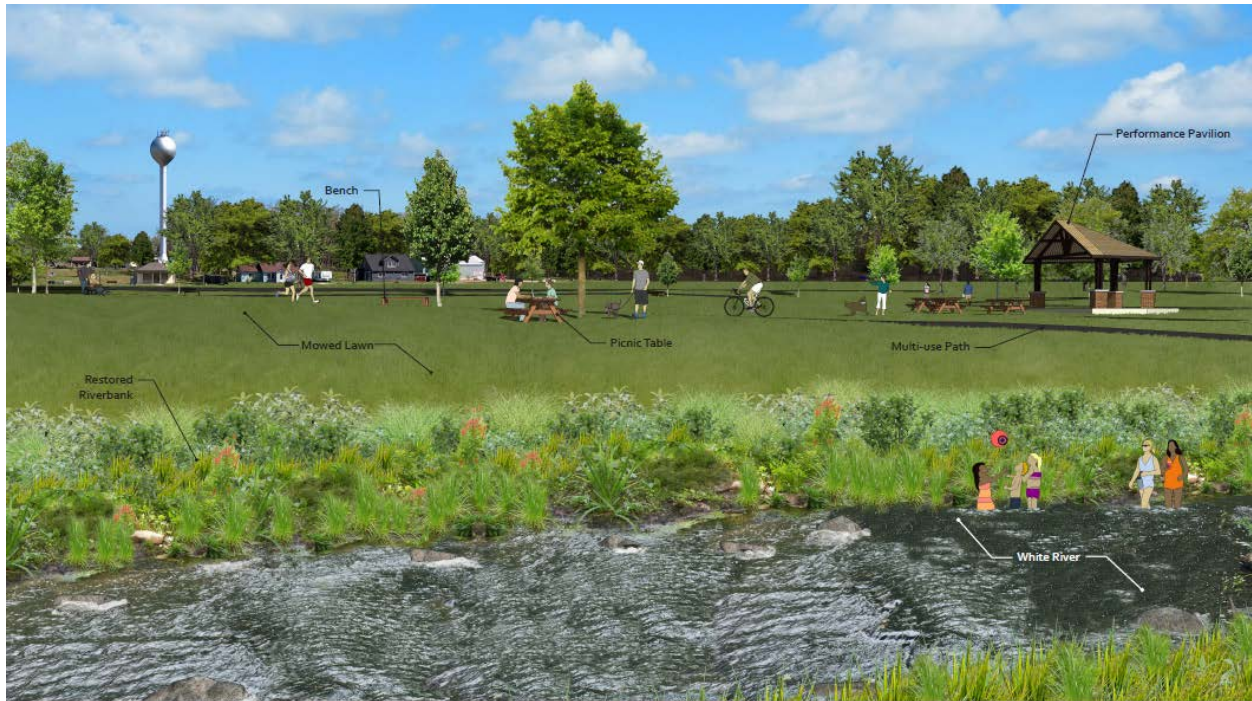
Figure 17: View from position just southeast of current dam site, looking northeast.

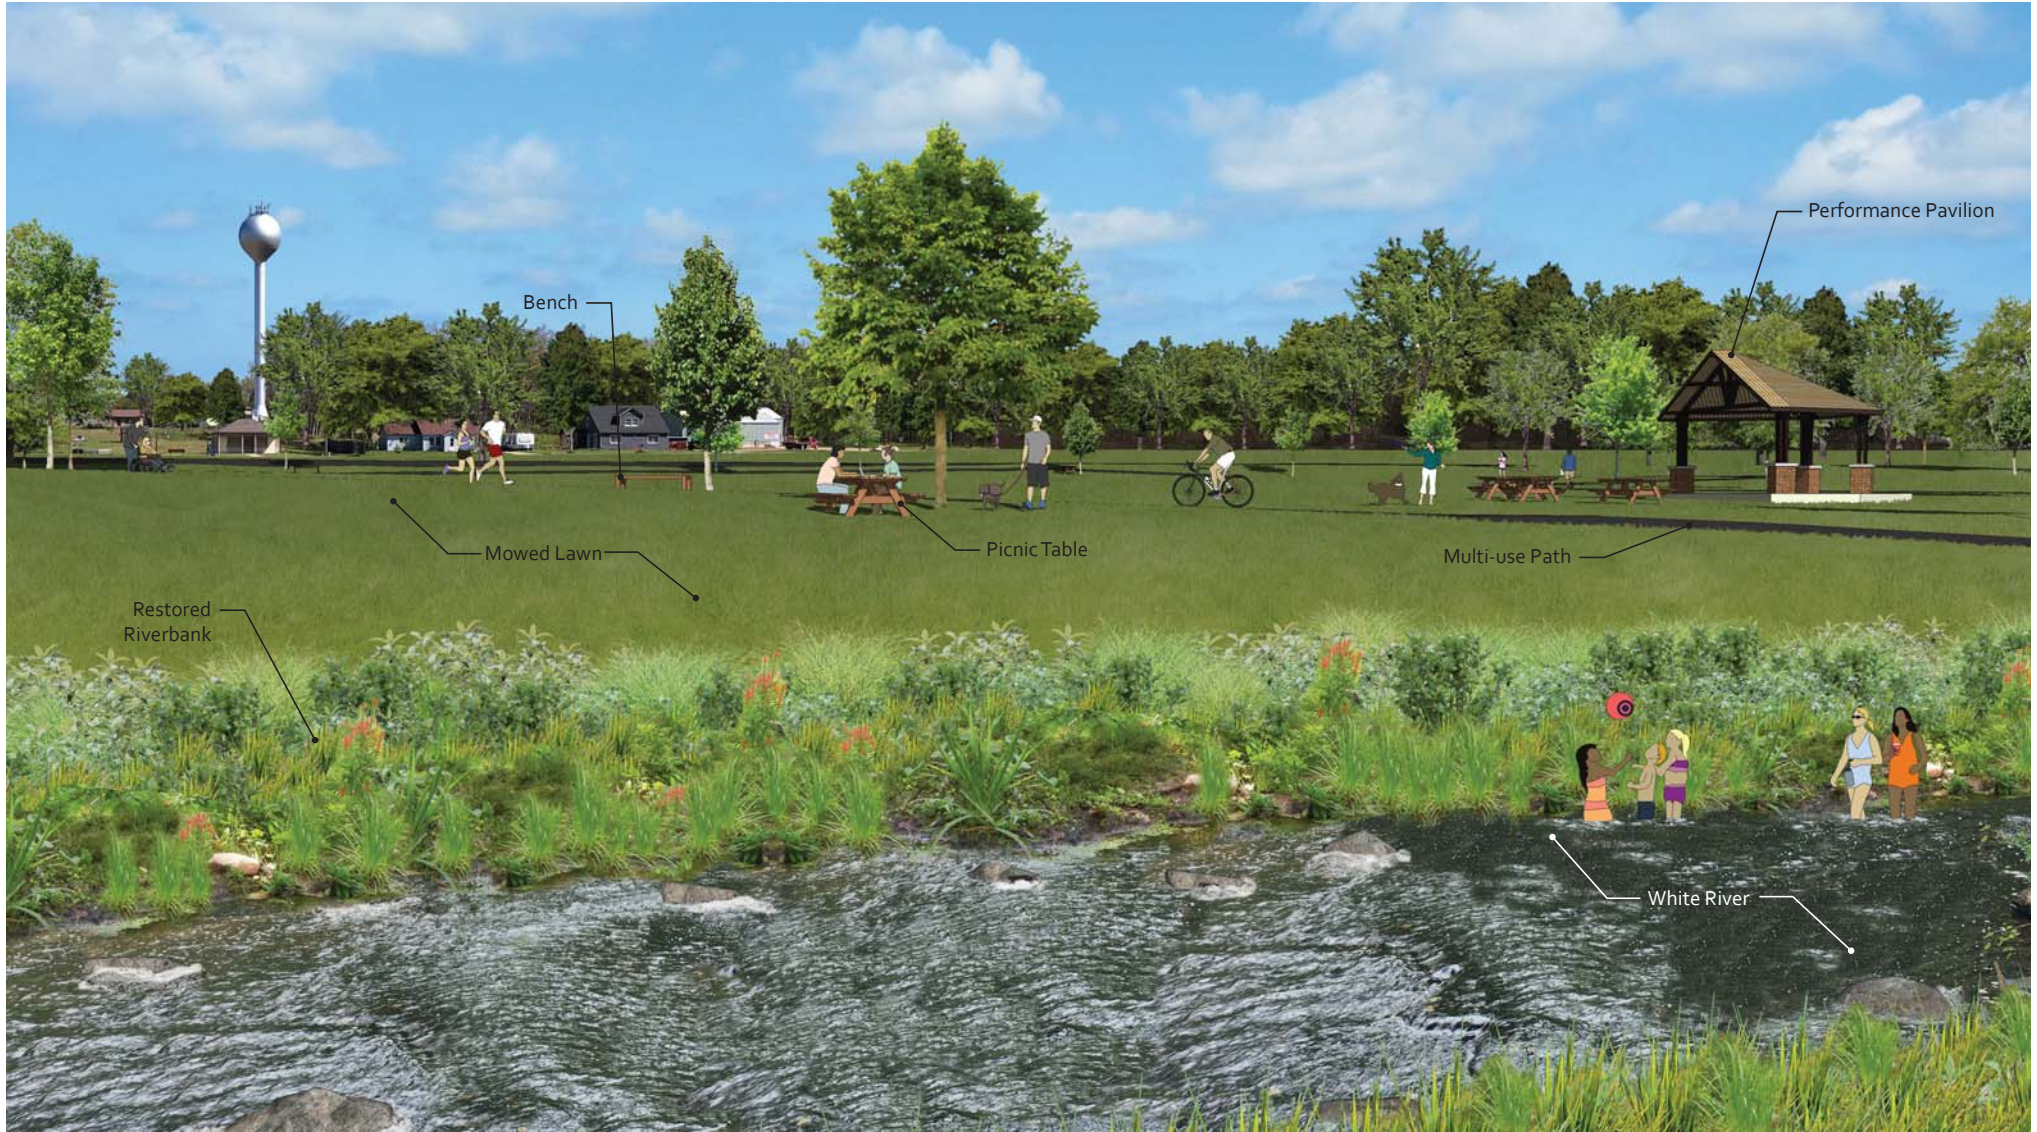
# View Looking North from S. State Street

White River Restoration  
White Cloud, MI

by the City of White Cloud and other riverside landowners. Full page versions of the renderings can be found in Appendix D.

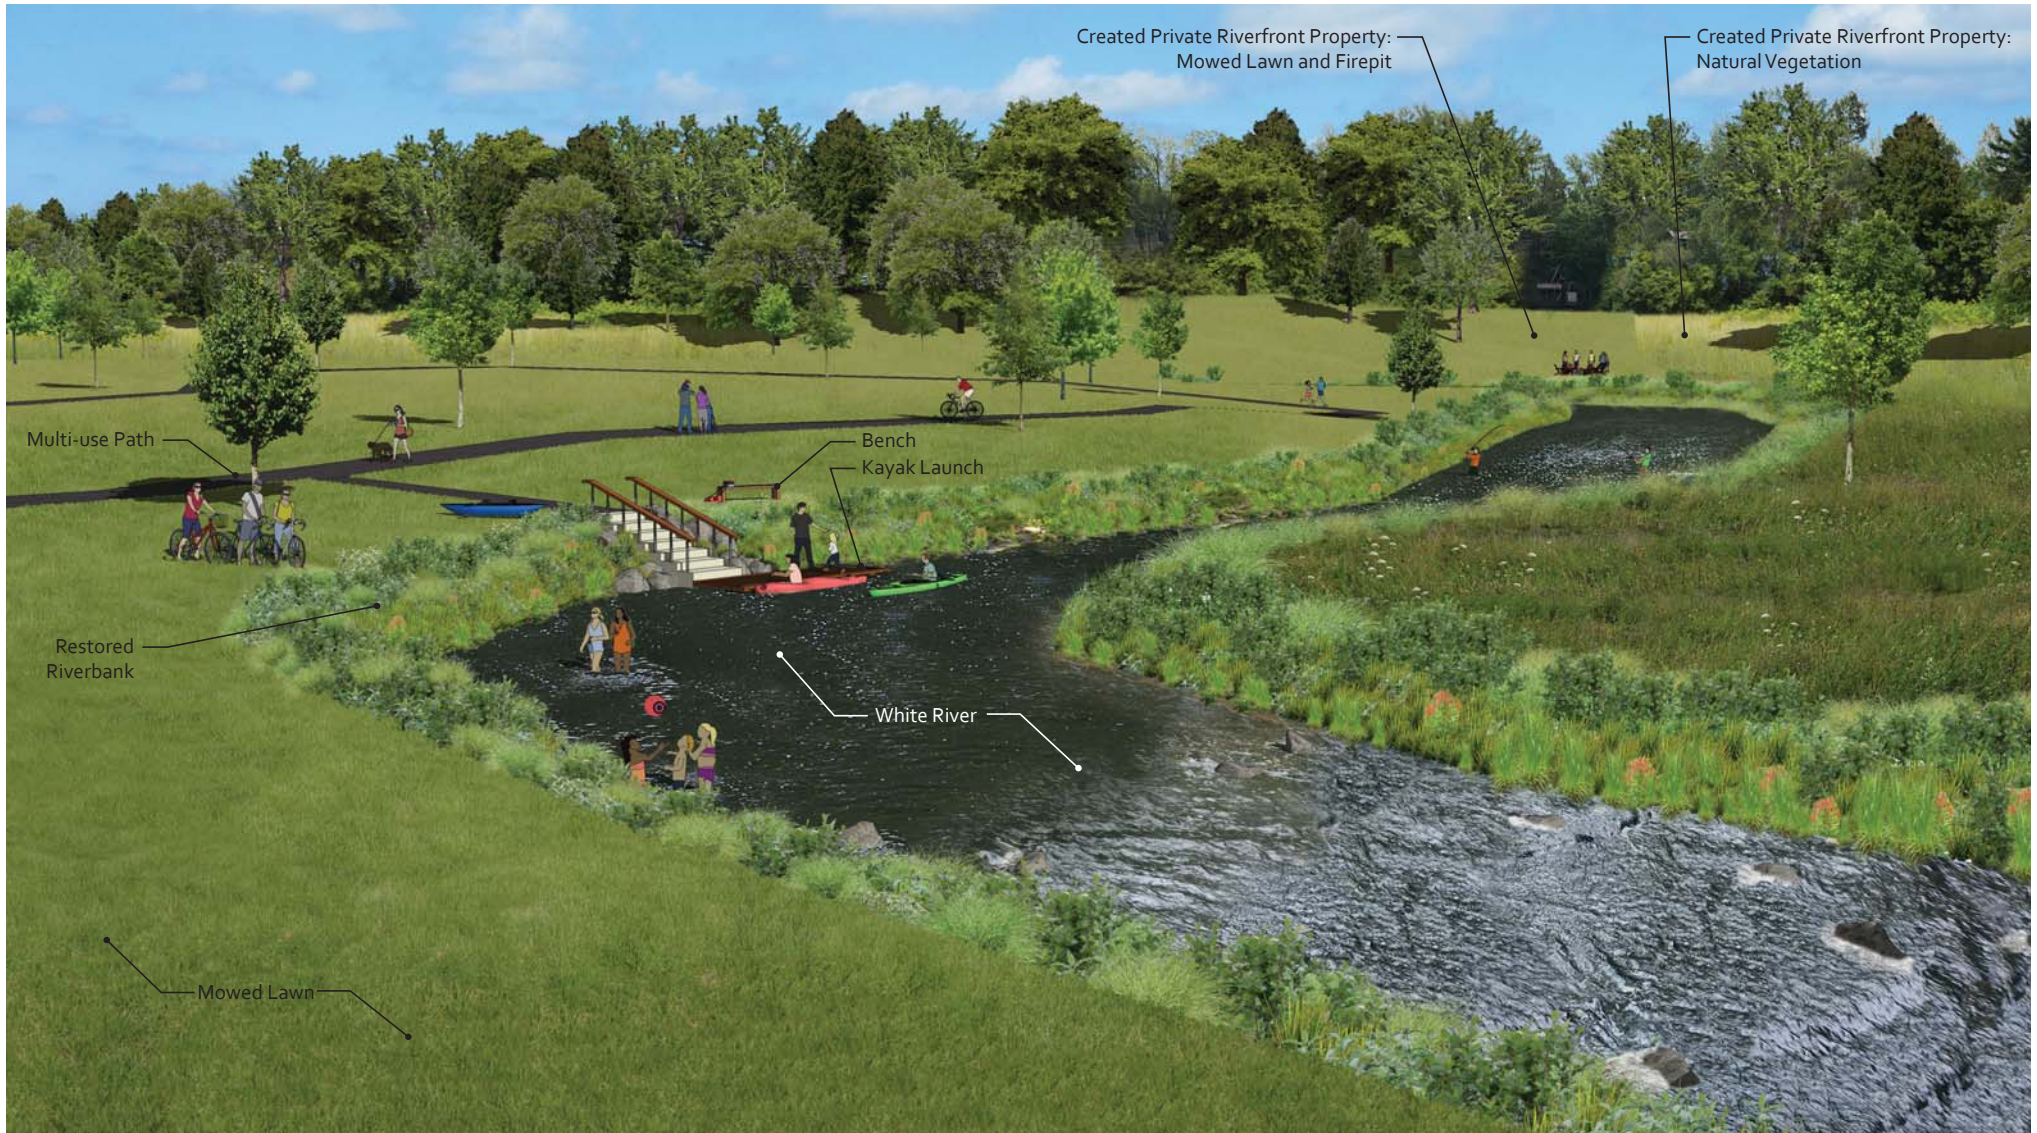
# View Looking South from S. State Street

White River Restoration  
White Cloud, MI
