## White Cloud Dam Removal Preliminary Analysis

#### Prepared by Trout Unlimited

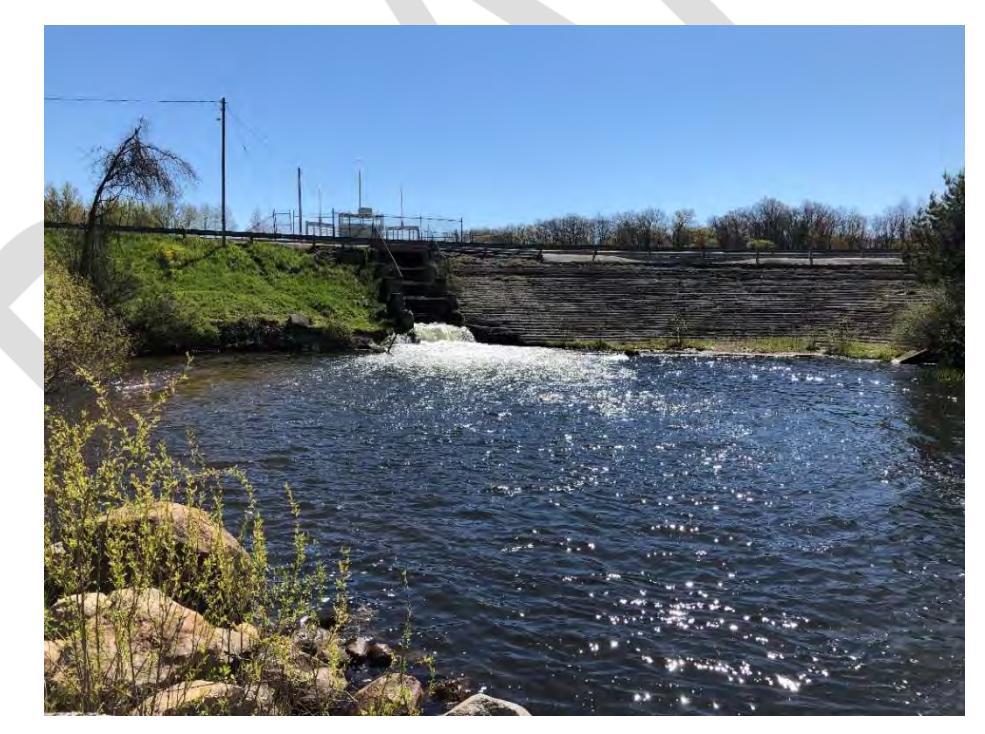
Figure 1: White Cloud dam spillway and embankment.

The White Cloud Dam is a 950-foot long embankment with three gated concrete spillways (Figure 1). On the south side of the dam the embankment is constructed of concrete and is slightly lower than the earthen embankment on the north side of the dam, creating a 140-foot long overflow spillway, designed to allow water to flow over the top of the dam during high flow conditions (Figure 2). There is an auxiliary gated spillway at the north end of the dam, designed to serve as an additional water release point (Figure 3).

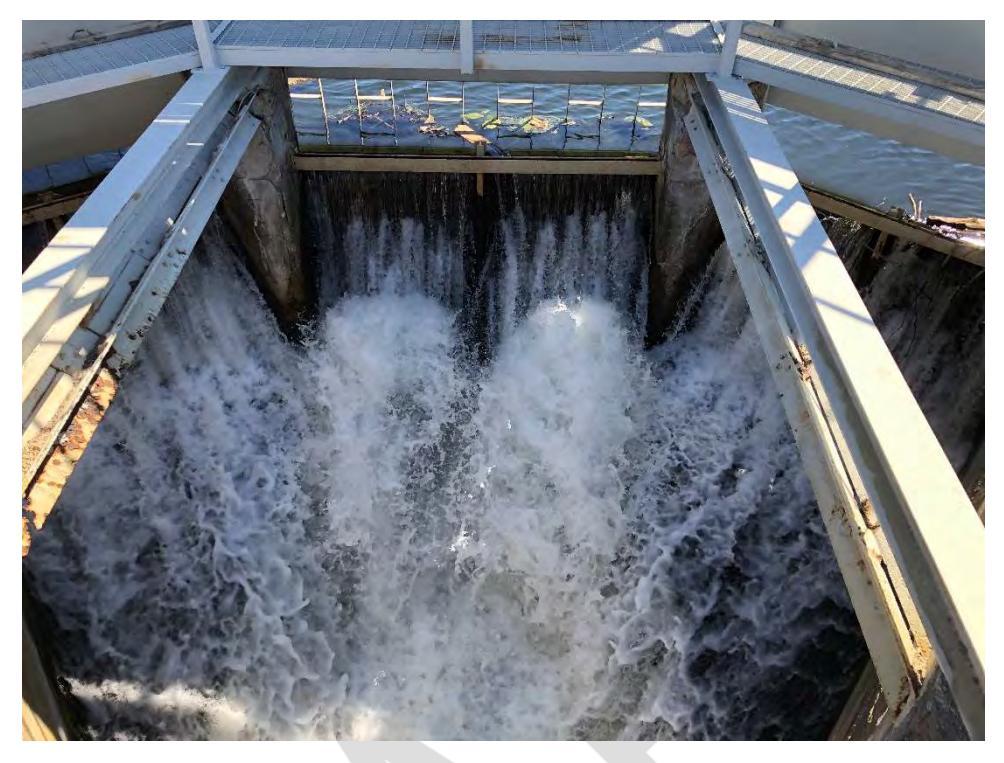
Figure 2: Spillway gate.

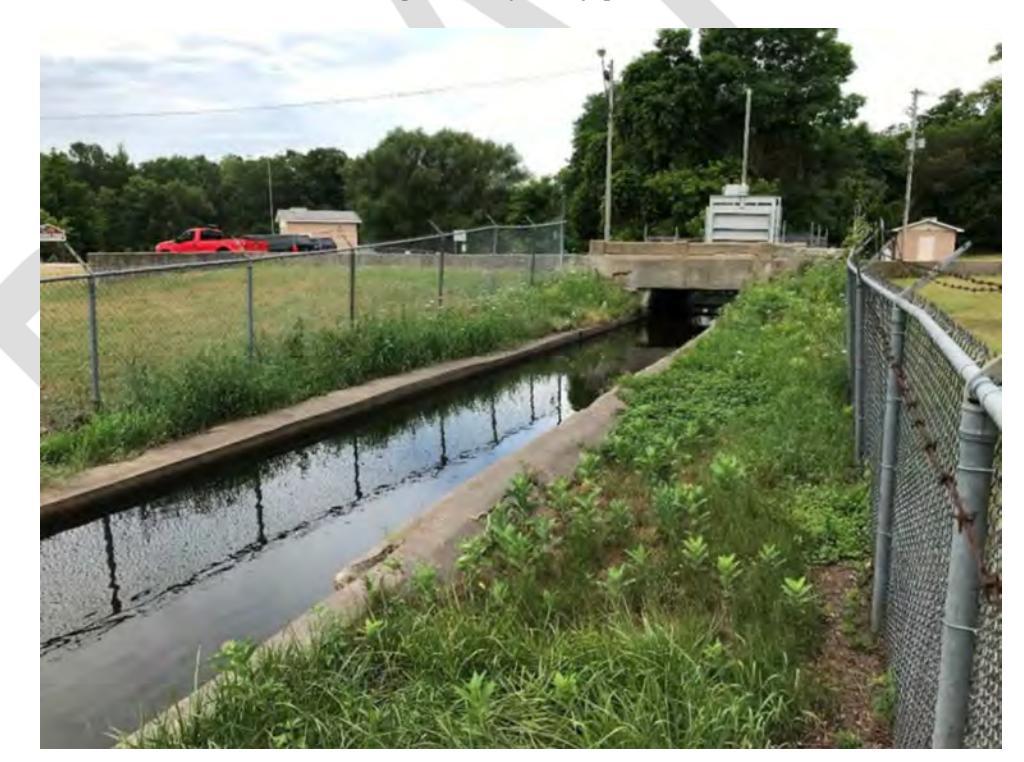
Figure 3: Auxiliary spillway intake channel. Photo; EGLE.

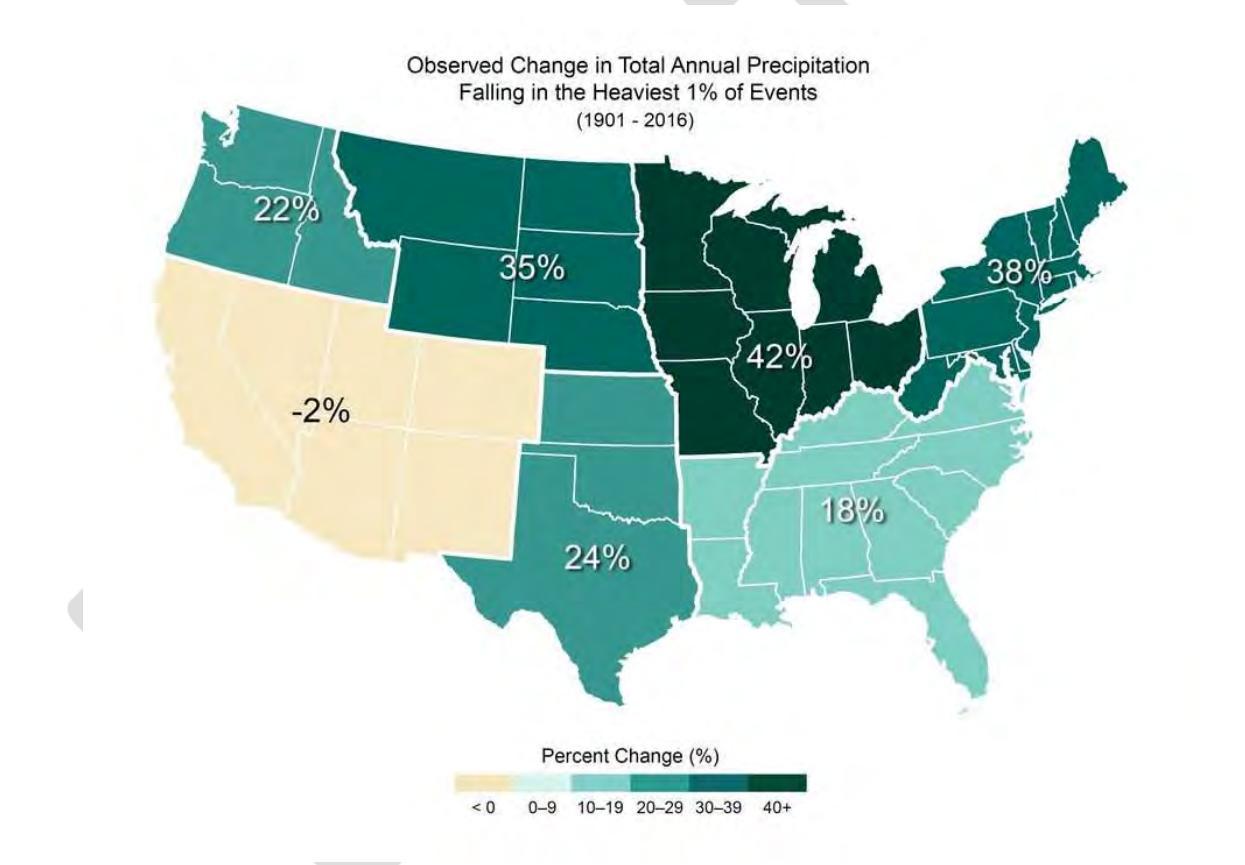
Figure 6: The Great Lakes Region shows a 42% increase in extreme precipitation over the past 100+ years (US Global Change Research Program, nd).

In addition to potential overtopping due to mis-operation, increases in the frequency and magnitude of precipitation events and flooding in recent years has called into question the accuracy of flood probability predictions (Figure 6). Overtopping often precedes dam failure causing approximately 34% of failures in the U.S. (Association of Dam Safety Officials, 2013).

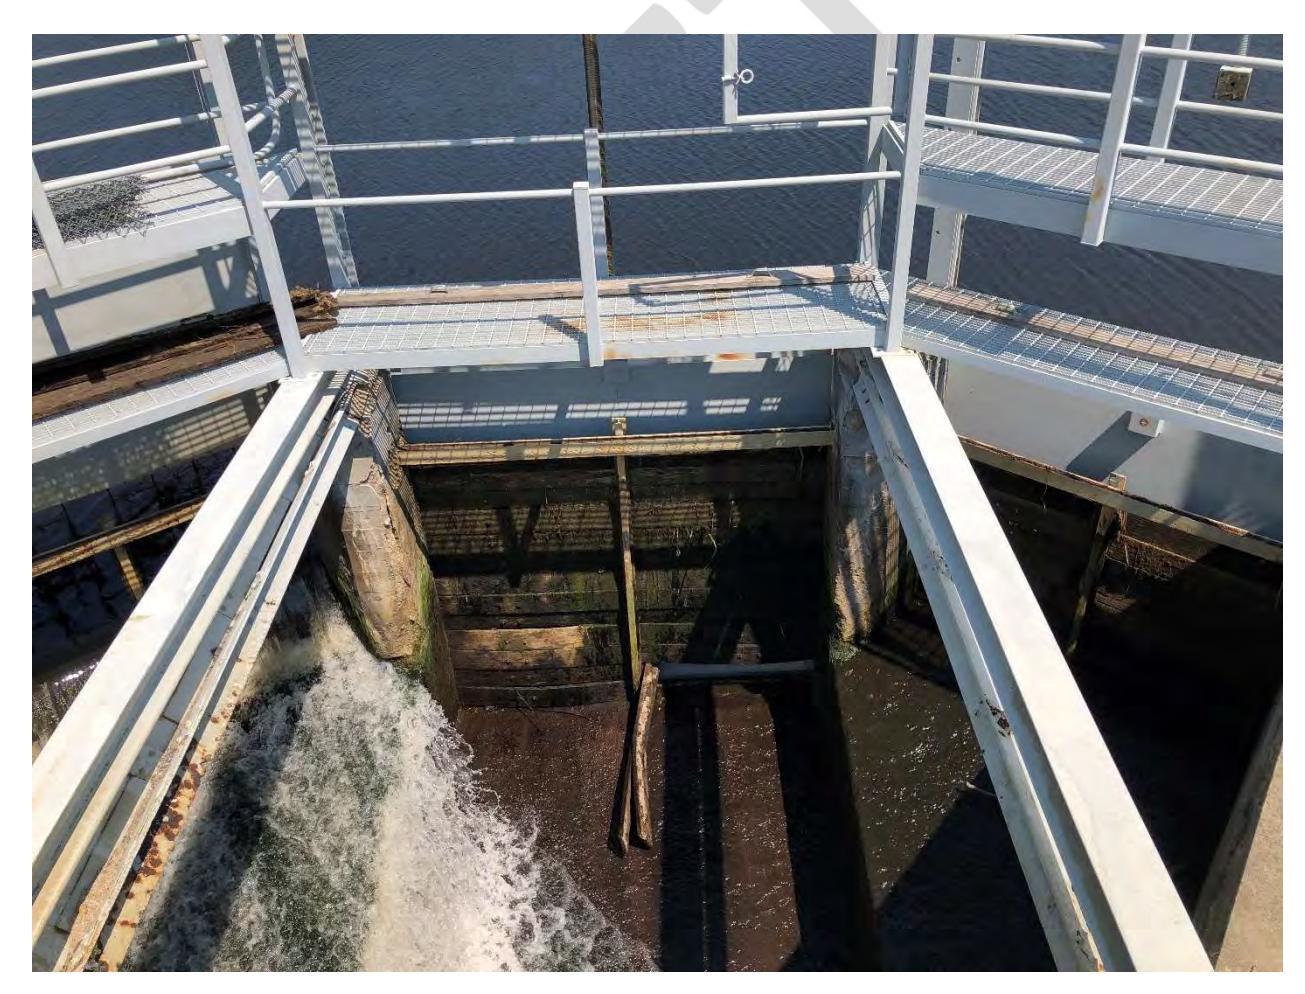
Figure 7: Stoplog failure in July 2021.

Stoplogs are used to adjust the water level in White Cloud Pond. When the dam gates are open, the stop logs impound the water, allowing water to spill over the top to maintain the specified water level in the pond. In July of 2021, two stoplogs failed at the primary spillway, causing White Cloud Pond to drop by approximately 10 feet (Figure 7). This issue was not identified in the previous inspection report. Not all parts of the dam are readily observable, and even with regular inspections, unforeseen issues can arise requiring additional resources and increased liability. All the stoplogs were subsequently replaced at a cost of \$650.

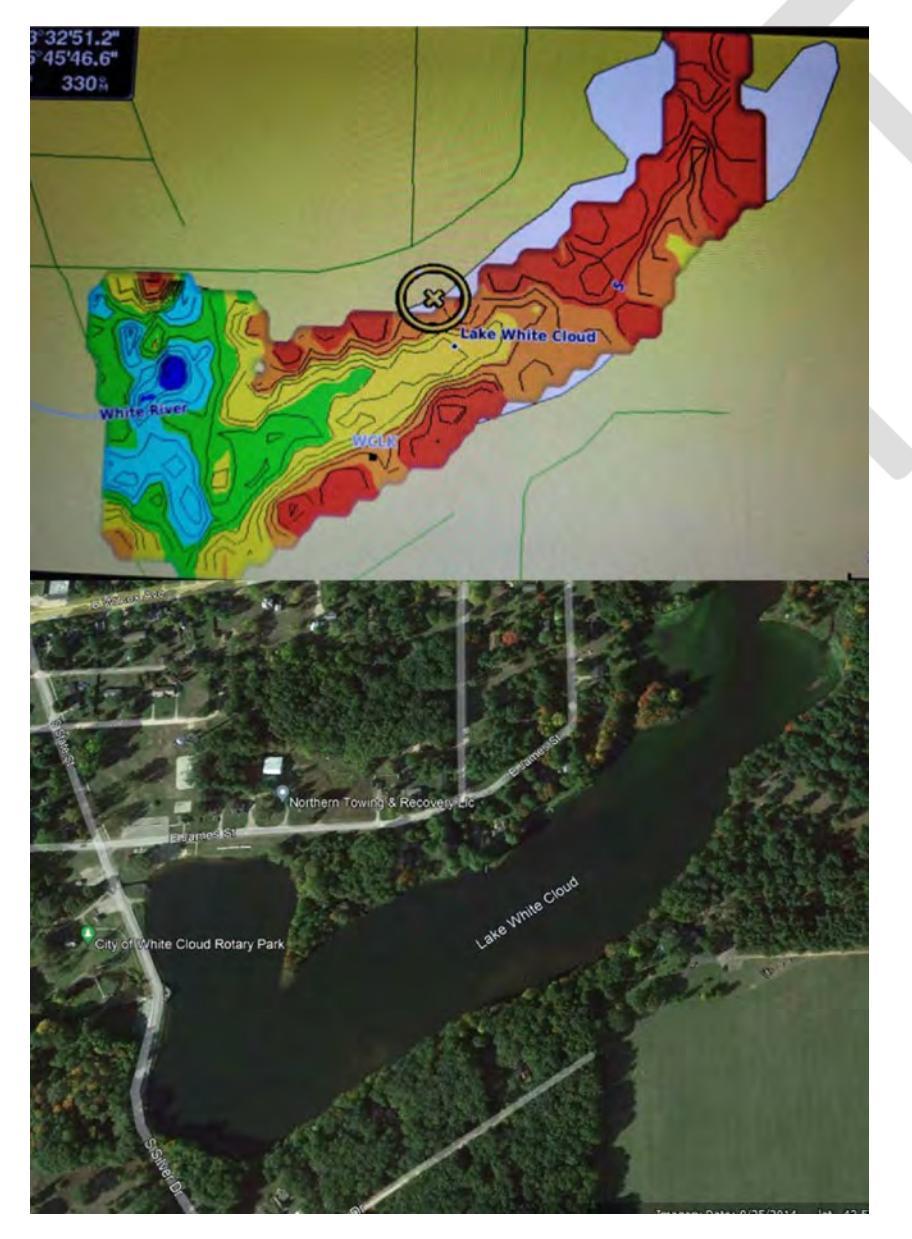
Figure 8: Bathymetric map of the White Cloud Pond Reservoir with aerial imagery of the same area.

> Red: <5ft Orange: 5-7ft Yellow: 7-10ft Green: 10-12ft Light Blue: 12-15ft Dark Blue: 15ft

The 42-acre White Cloud Pond is primarily used for swimming, fishing and boating. The pond has approximately 1.8 miles of shoreline and is deepest near the boat launch and swimming area, with a maximum depth of 18 feet (Figure 8). The pond becomes shallower to the northeast, away from the dam, eventually reaching an average depth of <4 feet. In general, the lower third of the pond's length, closest to the dam is the deepest with depths >10' common. The middle third of the pond length has begun to fill with sediment, and ranges in depth from approximately 4' - 10'. The upstream most portion of the impoundment has received significant sedimentation, and is now <5' deep (Figure 9). This section includes from M20 downstream to where the reservoir "bends", or turns and flows to the west towards the dam.

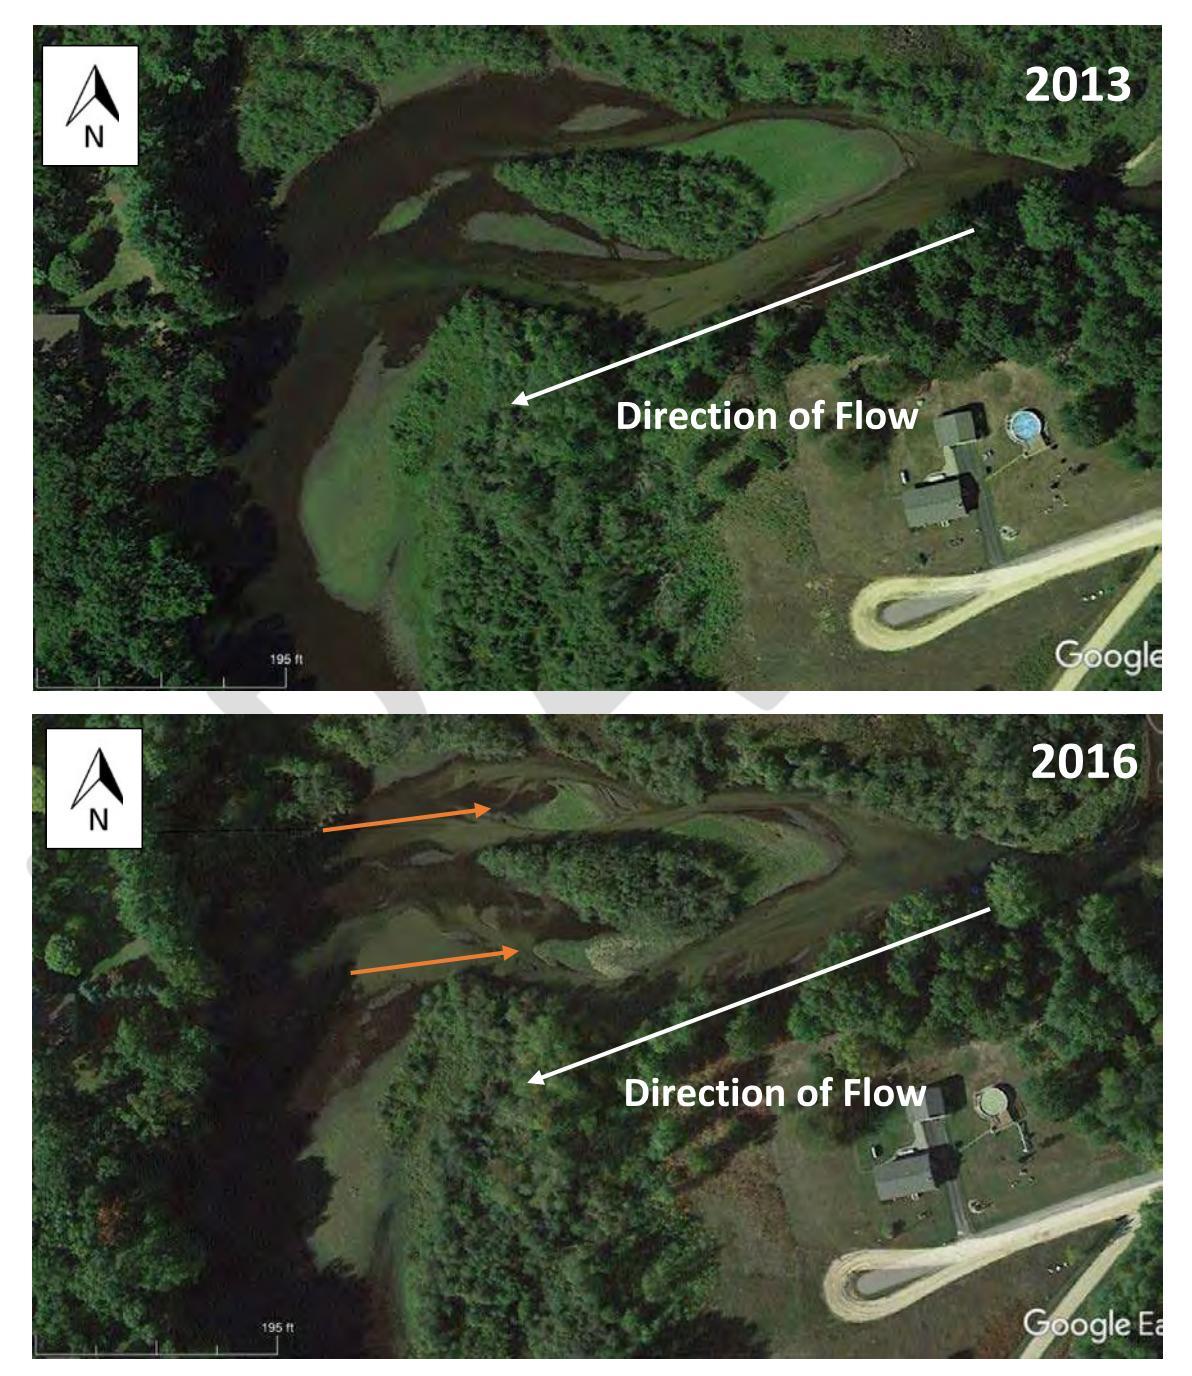
Figure 9: Aerial images of the uppermost portion of the White Cloud Impoundment indicates increased sedimentation between 2013 and 2016. Red arrows indicate areas showing increased sedimentation. This site is located just downstream of the M20 bridge.

Based upon visual assessments and historic records, White Cloud Pond appears to now be about midway through reservoir filling, yet without additional data on the sediment transport rate from upstream, we are unable to project how long the rest of the sedimentation process may take. Sediment can, in some cases, be addressed by removal through dredging to prolong the lifespan of the reservoir. However, dredging of submerged sediments is typically cost-prohibitive and thus limited as a practical means for managing sediment.

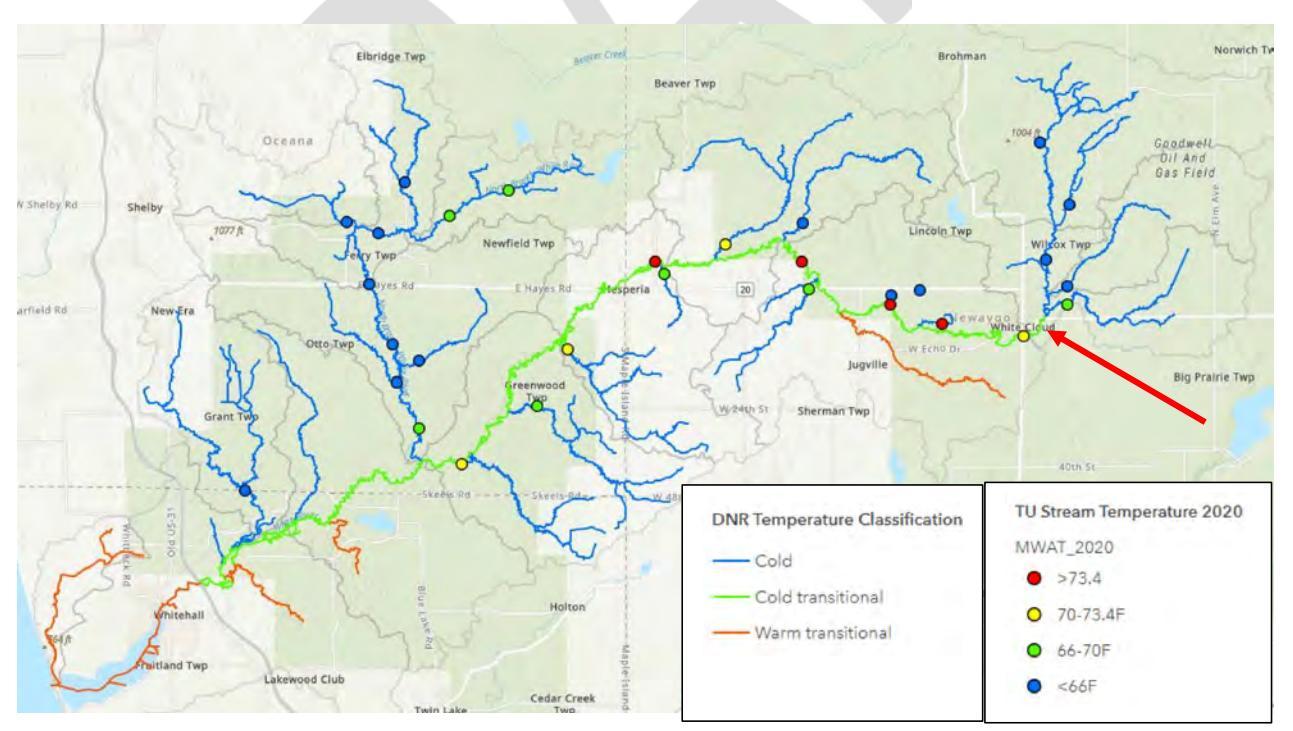
Figure 11: Temperature monitoring results show high quality coldwater habitat (blue dot) above White Cloud Pond, transitioning to marginal coldwater habitat (yellow) below the dam. Red arrow indicates the location of the dam.

University (Lessard and Hayes, 2003; see Figure 10 below). The temperature impact was again documented by TU in 2020, when an eight degree increase in water temperature below the dam as compared with upstream of the dam was measured (Figure 11). As a result, the White River downstream from White Cloud Dam provides marginal habitat for coldwater fish such as trout. To mitigate this loss in coldwater habitat, the DNR annually stocks brown trout at various locations in the White River downstream of the dam to provide angling opportunities. From the research and data collected, if the dam were removed, it is predicted that brown trout and brook trout would naturally reproduce and survive at higher abundances downstream of the dam than stocking allows.

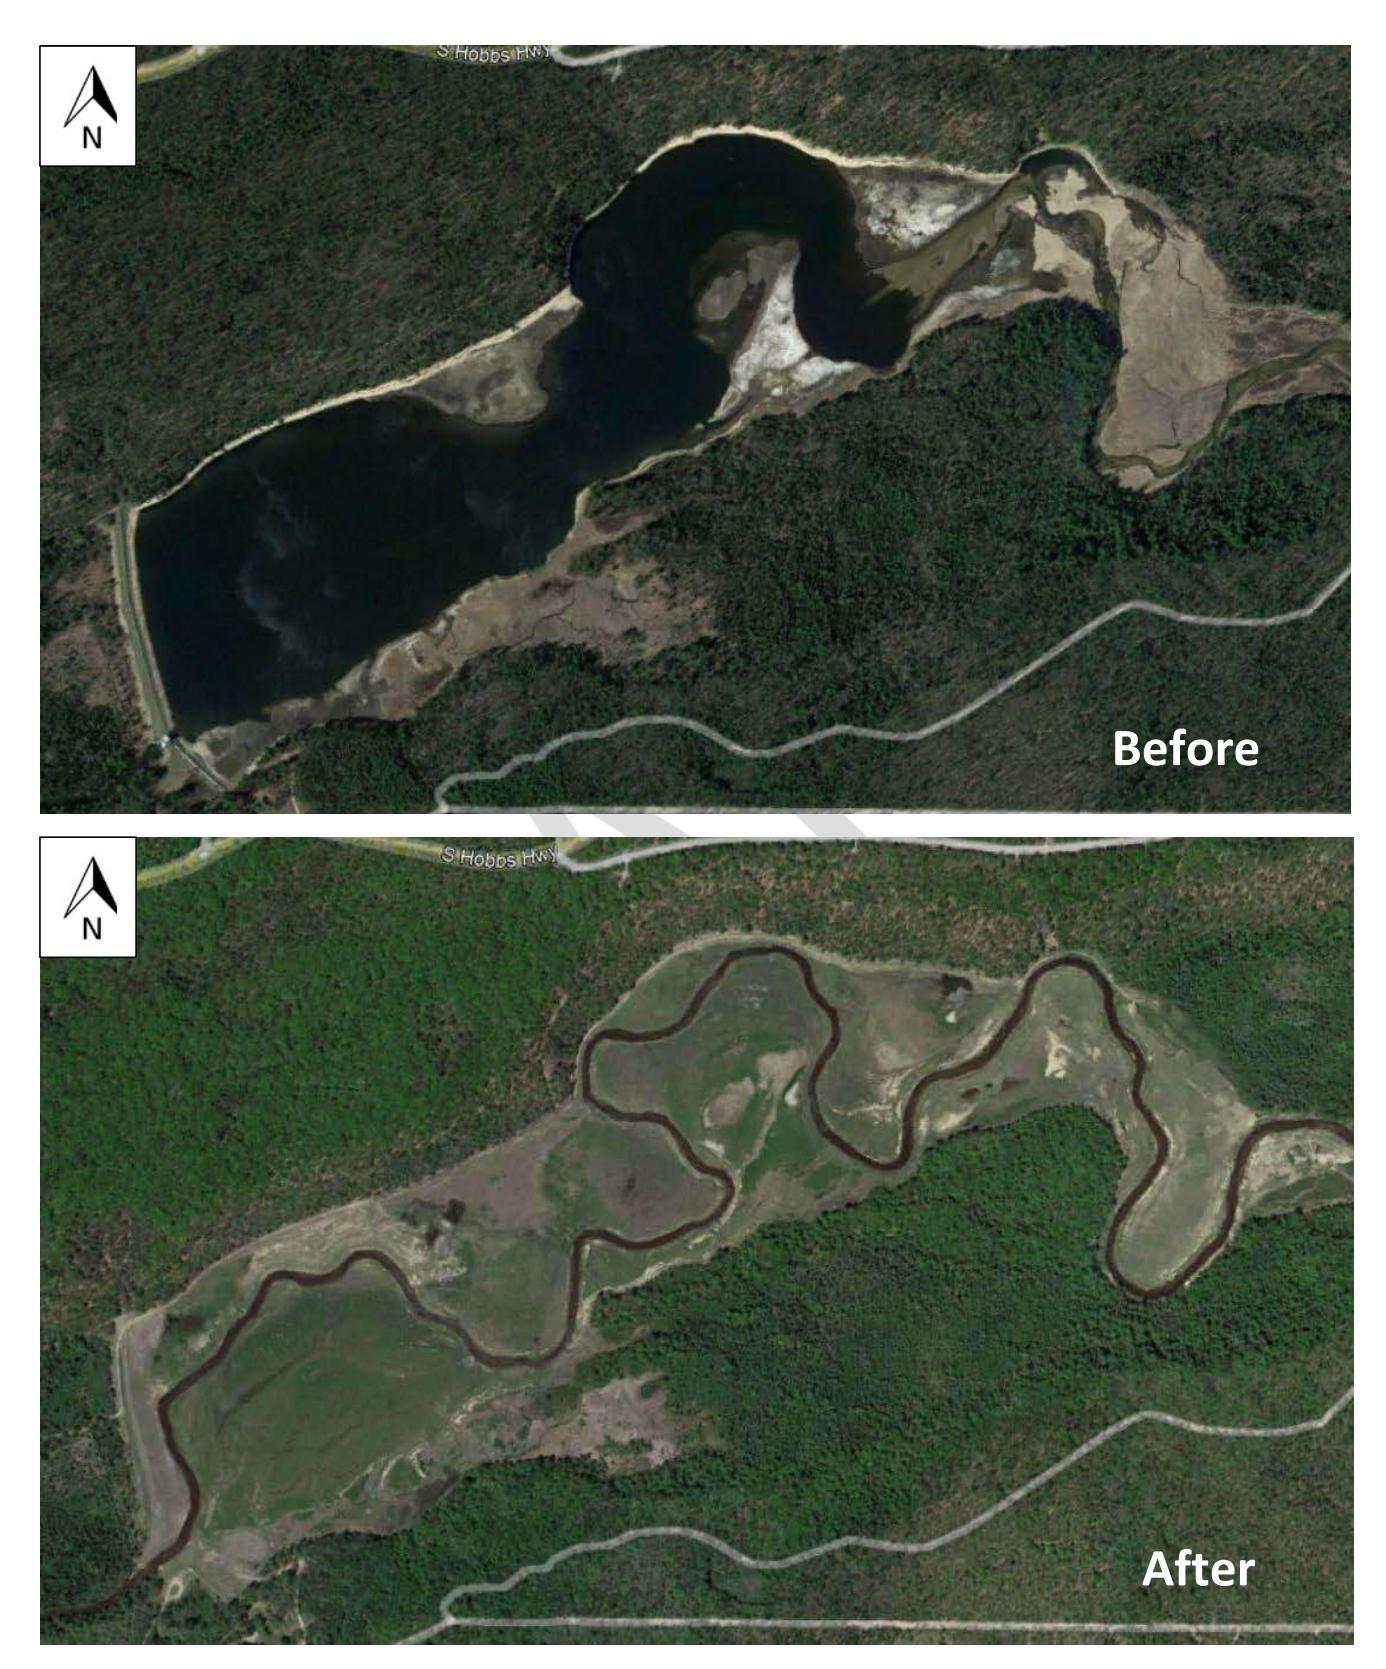
Figure 12: Aerial image of Boardman River before/after removal of the Brown Bridge Dam.

In this case, the former impoundment area will turn into a flowing stream section, with wide prairie-like settings surrounding it where the impoundment had flooded. However, individual landowners of the exposed impoundment bottomlands can often decide how they will manage that property. Some owners may choose to actively mow the property and manage it as added lawn; others may choose to let a natural grassland like area develop and maintain it by cutting tree growth; and others may help a forested vegetation takeover by planting trees of their choosing or allowing natural trees to grow. Figures 12 and 13 show two Michigan rivers before and after dam removal. Before/after images show the transition from an impoundment to a river. More aerial images of dam removal sites can be found in Appendix A.

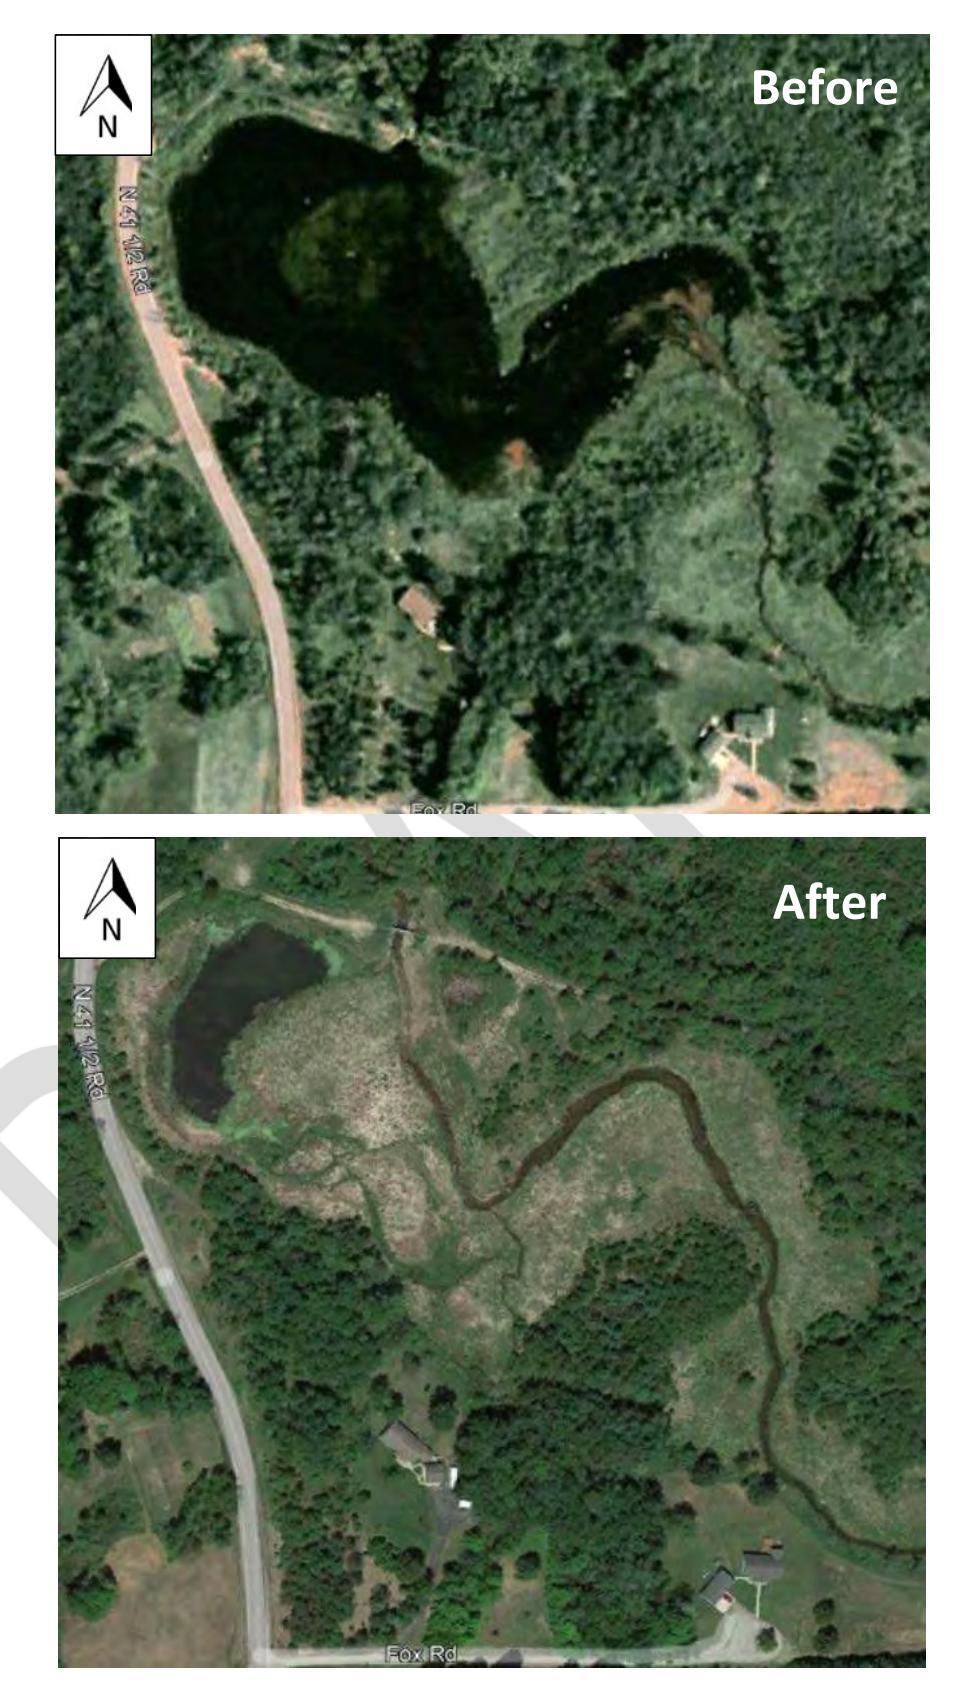
Figure 13: Aerial image of Manton Creek before/after removal of Mill Pond Dam.

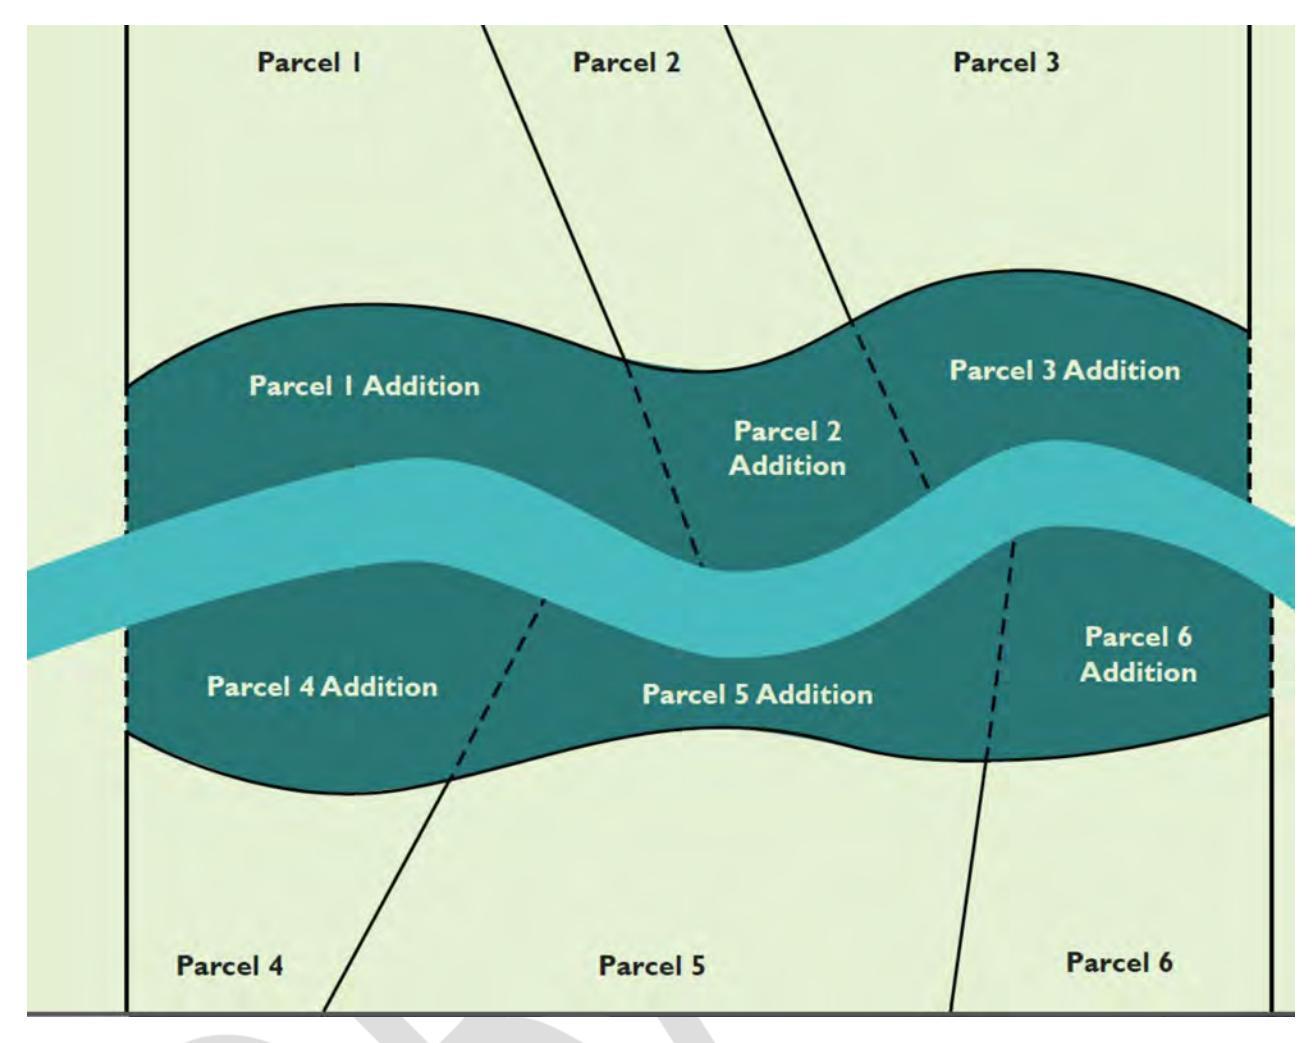
Figure 14: Conceptual representation of potential parcel expansions with newly exposed land. Dark green represents an existing pond. The blue represents the river that would form after dam removal. The parcel additions are newly exposed bottomlands that are added to adjacent properties.

If the dam were to be removed and the water level lowered, 30 or more acres of land will be exposed, possibly leading to questions of ownership due to inconsistent parcel boundary descriptions and references. The variable property descriptions can cause confusion and discord, as landowners sort out new property boundaries. In some dam removal cases, newly exposed lands (without clear ownership asserted) are turned into public parks and river access. But an alternative that may be suitable in this situation is to assign the newly exposed lands to the adjacent property owners. This would allow them to maintain waterfront property status, and will increase the size of the parcels, both benefiting property value. One simple strategy to accomplish this would be to extend property lines until they reach the river's edge, or center thread of the river channel. See example of this approach below in Figure 14. Many strategies are possible for dealing with the newly exposed land ownership. As this has legal components, and ramifications to adjacent property values and taxation, this is a key element to proactively address.

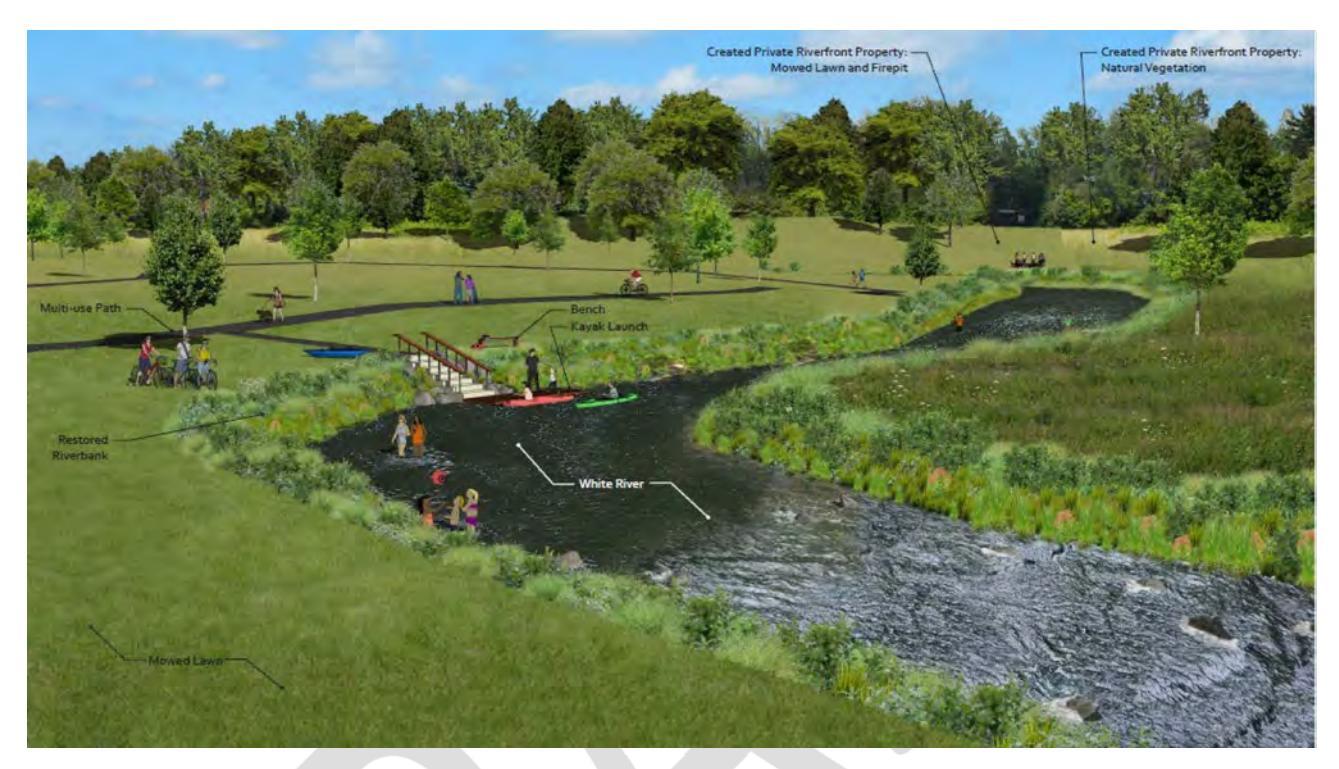
Figure 15: View from current White Cloud Dam site, looking southeast.

At the conclusion of dam removal and restoration the site will look quite different. Where there was a small pond, a river would flow. The size of the river will be comparable to nearby upstream and downstream reaches. The river will follow the old river channel, meandering through the area once inundated by the pond. The adjacent, newly exposed, land surface will be managed according to the wishes of landowners. The renderings below were developed to aid the community of White Cloud in visualizing what the site could look like post-dam removal. It is important to note that this is a conceptual rendering, and the actual site outcomes for the newly exposed lands would be determined

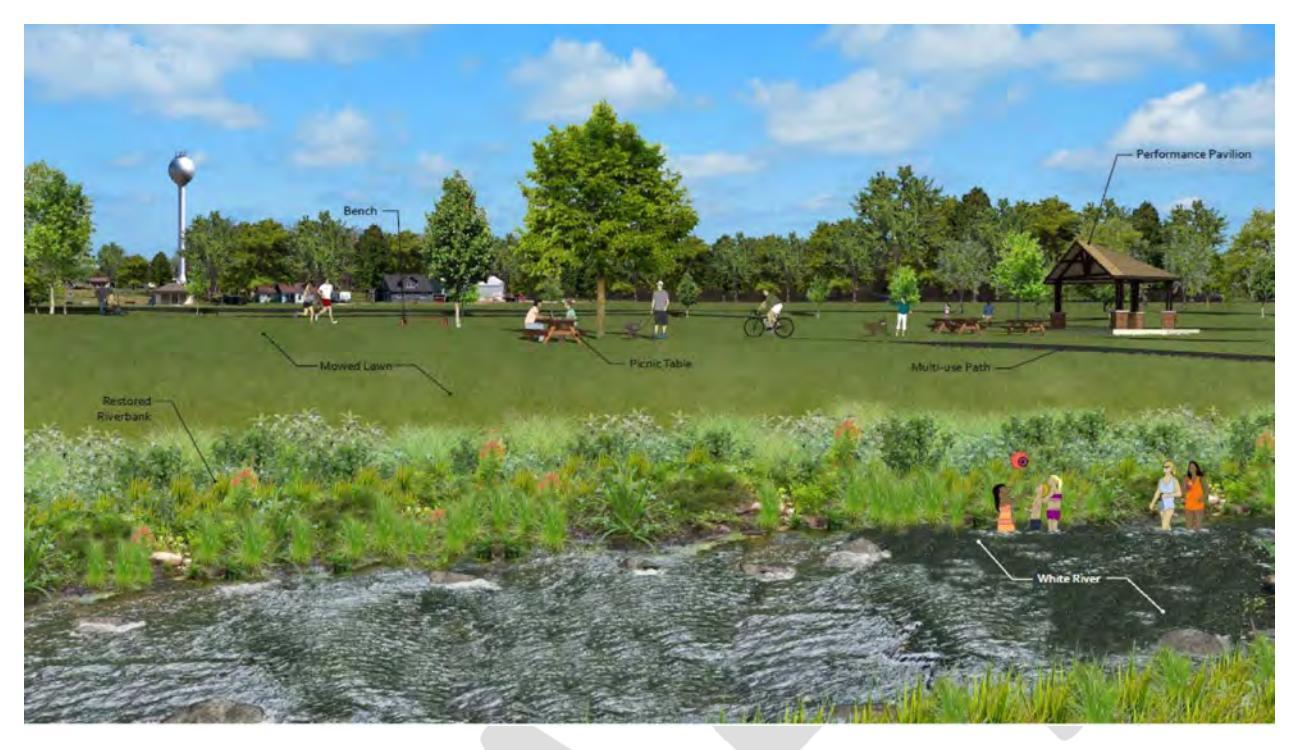
Figure 17: View from position just southeast of current dam site, looking northeast.
