## White Cloud Dam Removal Preliminary Analysis

#### Prepared by Trout Unlimited

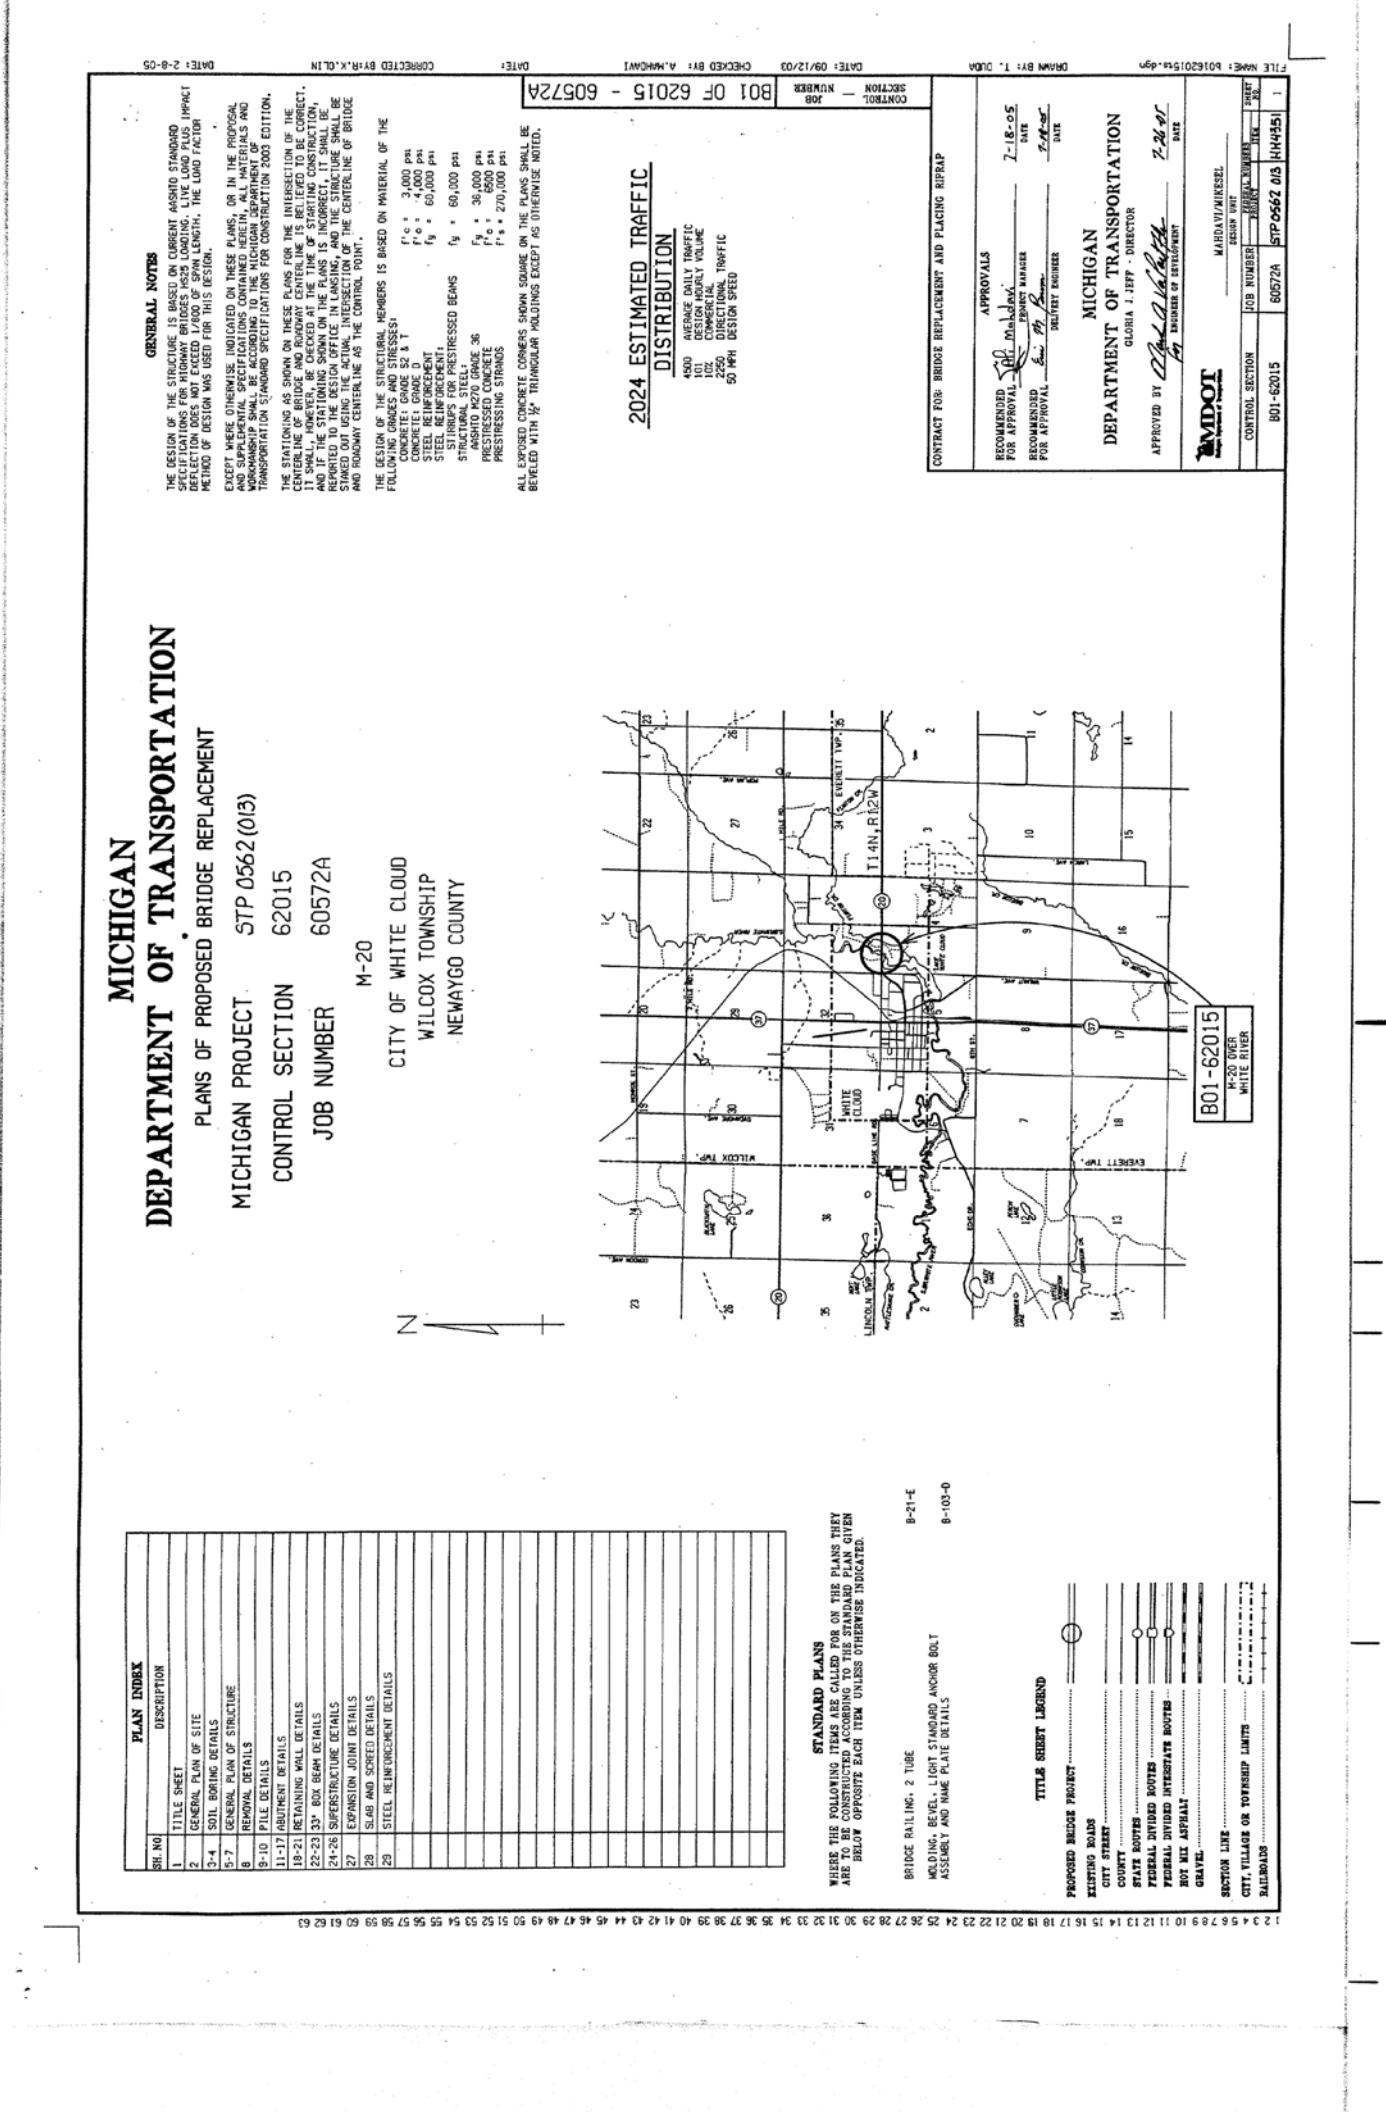
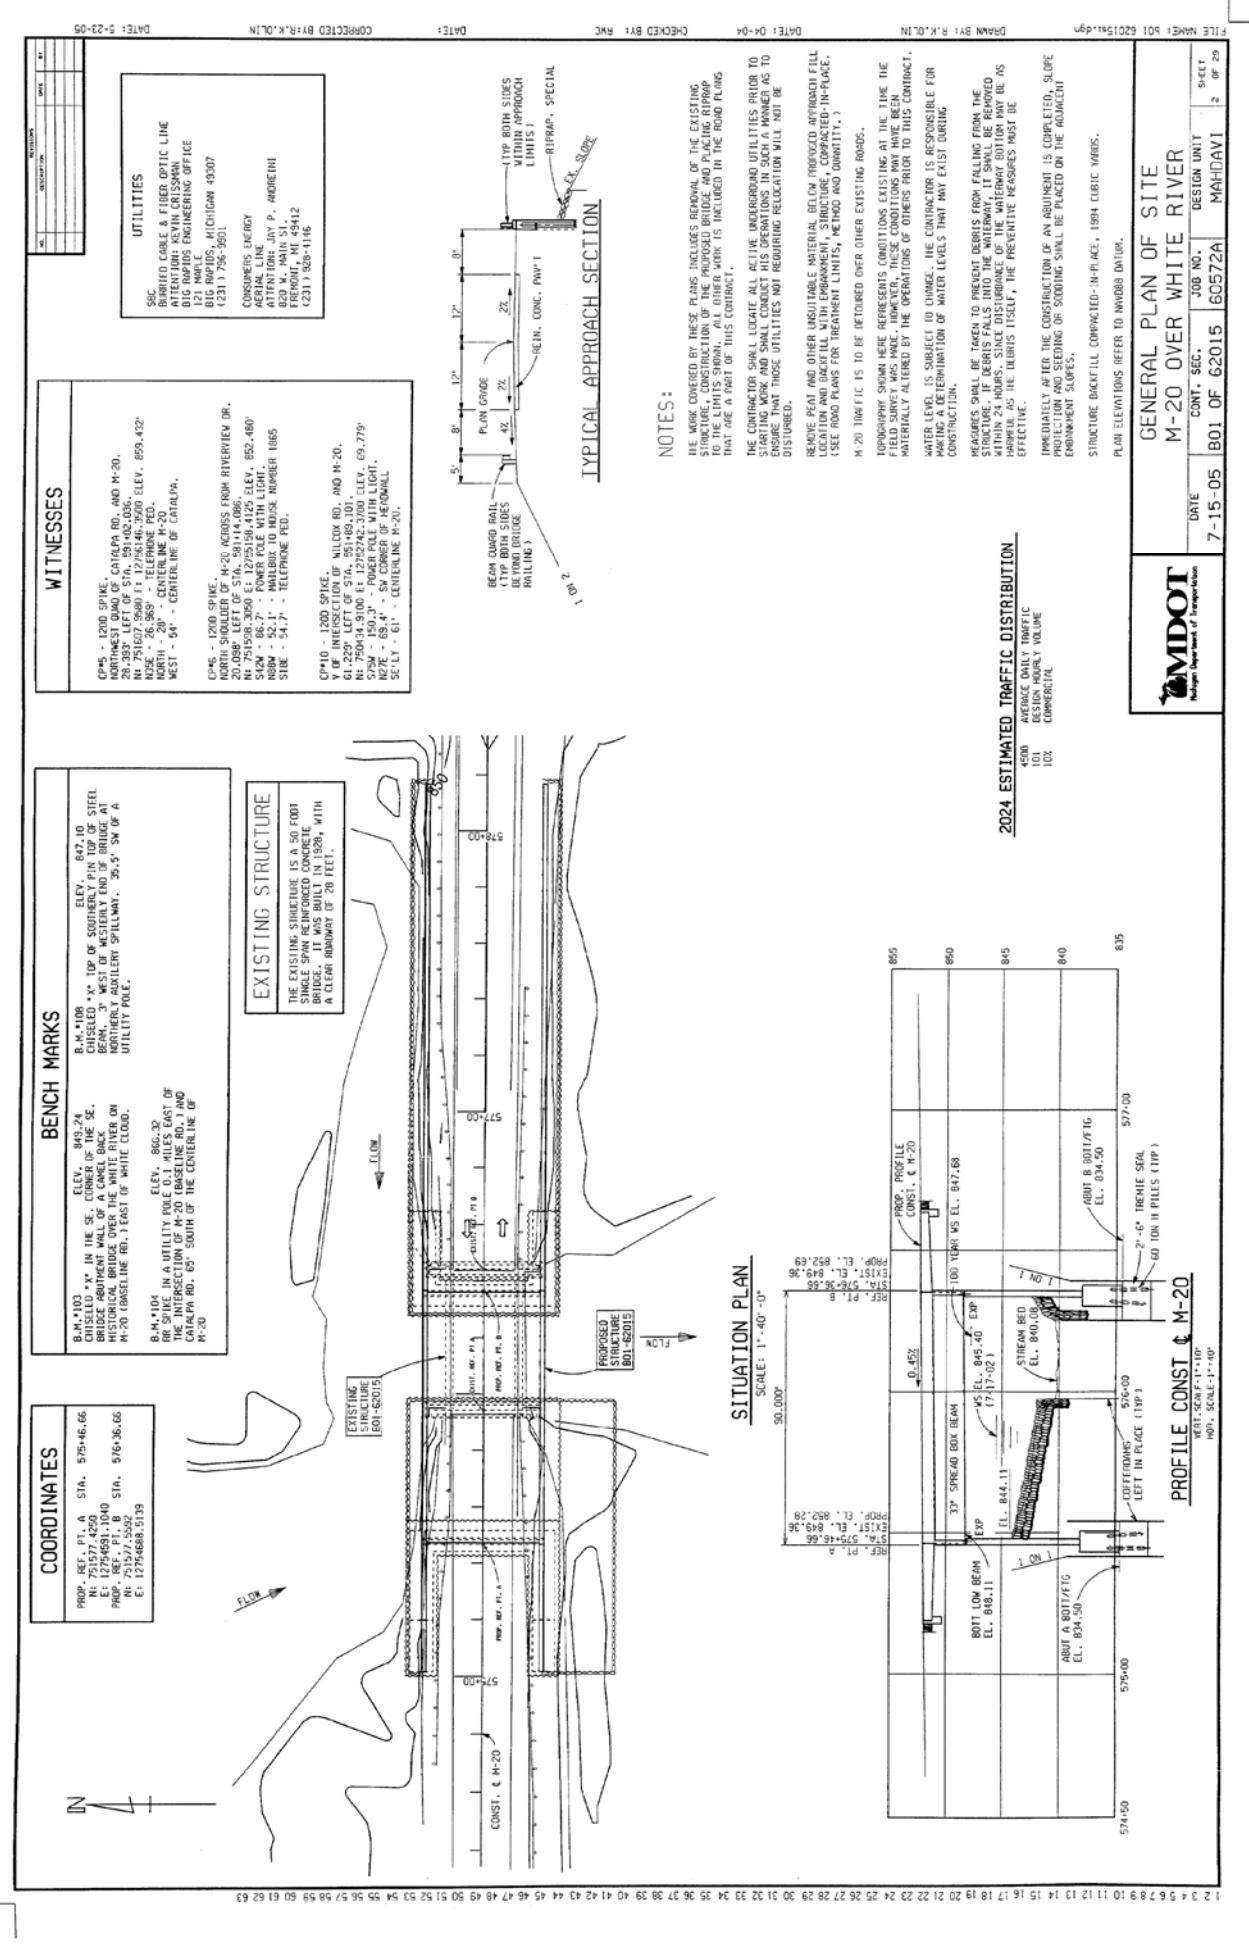
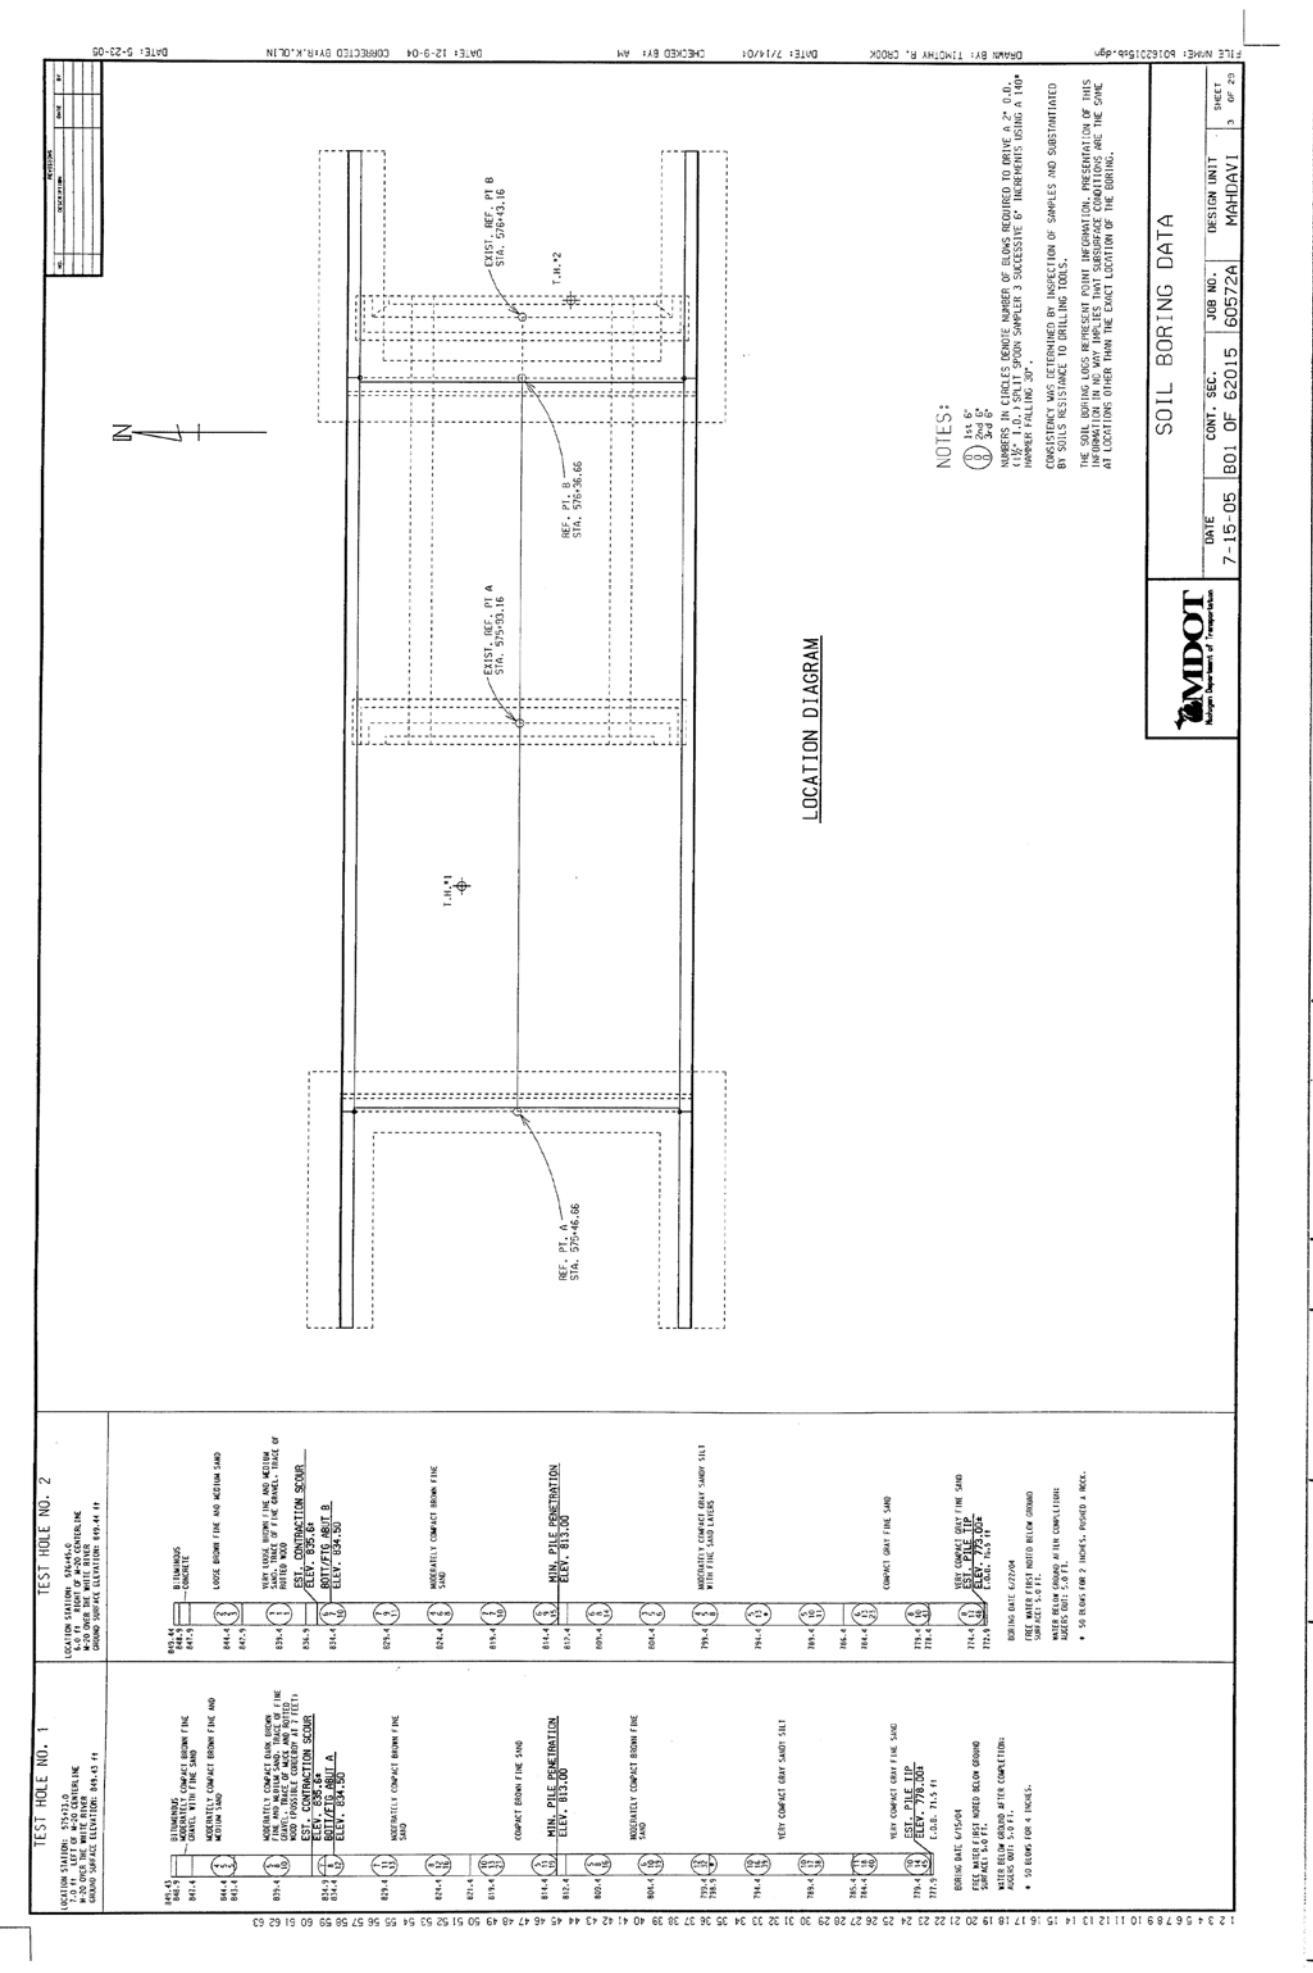
M20 Bridge Plan Set

The second road consideration in removing the dam is M20. The M20 bridge is located across the White River in an area that is still part of the impoundment (while narrower here, the water elevation is still affected by the dam). This poses a consideration and concern for design of a dam removal, in that the river may incise, or cut, downward enough to cause issues with the road embankment stability and or
